**Richard Johnson & Associates, Vista Canyon Project Off Site Oak Tree  
Report, City of Santa Clarita (February 2010)**

RE: **Vista Canyon Project- Off Site Oak Tree Report**  
**City of Santa Clarita, California**

**Table of Contents**

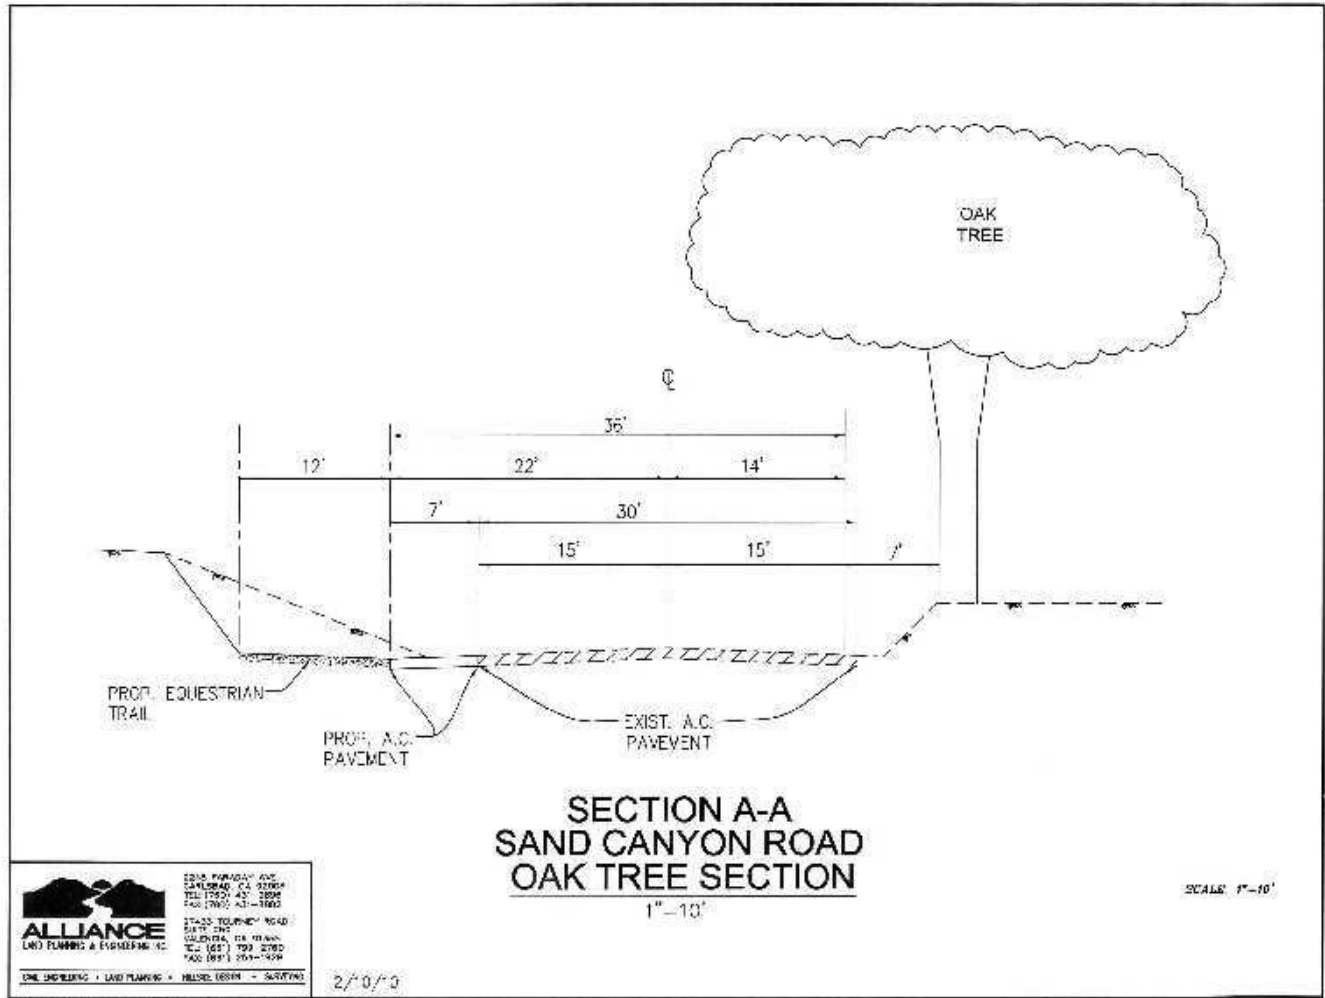
#### Tree #25B

Tree#	Notes	Recommendations as for current condition.
<b>25B</b>	Tree is located approximately 7 feet to the east of the pavement for Sand Canyon Road .3 miles south of the Sand Canyon/Lost Canyon intersection. Tree displays old fire damage/scars. Some hollow/decay at root buttress is previous fire and/or mechanical damage due to adjacent road. Some pruning wounds. Crown has been pruned high for vehicular clearance. Some epicormic growth from old wounds in upper canopy. Some included bark at main crotch. Pit in upper secondary crotch. Top of crown slightly thin. Some landscaping under the tree includes turf on the east side and succulents/natives on the west side. Except for the existing planter (approx 14'X35') tree is surrounded by pavement.	None.
<b>45</b>	Tree is located approximately 4 feet north of the pavement for Lost Canyon Road and west of the Sand Canyon/Lost Canyon intersection. Tree displays old fire damage/scars. Deep cavity/hollow in trunk. Some hollow section of upper main limbs. Old major wound closure at east base of trunk. Evidence of Oak Twig Girdler damage throughout canopy.	None. Oak Twig girdler is a common pest among this species and control is generally not warranted.

Tree#	Notes Based on information provided by client	Recommendations
25B	As detailed on Sand Canyon Road Oak Tree Section A-A, existing pavement dimensions will be increased, primarily on the south side of the road. Minor grading will be needed to create the additional road bed.	<p>Protective fencing must be installed around tree prior to and during entire encroachment period. All work within the “Protective Zone” must be monitored by project Arborist or similarly qualified person.</p> <p>Due to the fact that proposed infrastructure improvements closely match the existing infrastructure dimensions, tree impacts are expected to be minimal. In the case of root structure exposure due to proposed construction, all roots should be cleanly cut back to below grade, backfilled with soil and surrounding soil soaked with water.</p>
45	As detailed on Lost Canyon Road Oak Tree Section A-A, approximately six feet of pavement would be removed and replaced with curb, gutter and a decomposed granite trail. Minor grading will be needed. Pruning will be needed to provide a minimum of 12 ft clearance over the trail.	<p>Protective fencing must be installed around tree prior to and during entire encroachment period. All work within the “Protective Zone” must be monitored by project Arborist or similarly qualified person.</p> <p>Due to the fact that proposed infrastructure improvements closely match the existing infrastructure dimensions, tree impacts are expected to be minimal. In the case of root structure exposure due to proposed construction, all roots should be cleanly cut back to below grade, backfilled with soil and surrounding soil soaked with water.</p> <p>The portion of the canopy that will need to be pruned for clearance is minor and is not expected to severely impact tree health.</p>
