WILEY CANYON (SMISER RANCH) MIXED USE DEVELOPMENT

Oak Tree Report

April 2020; Revised February 2024

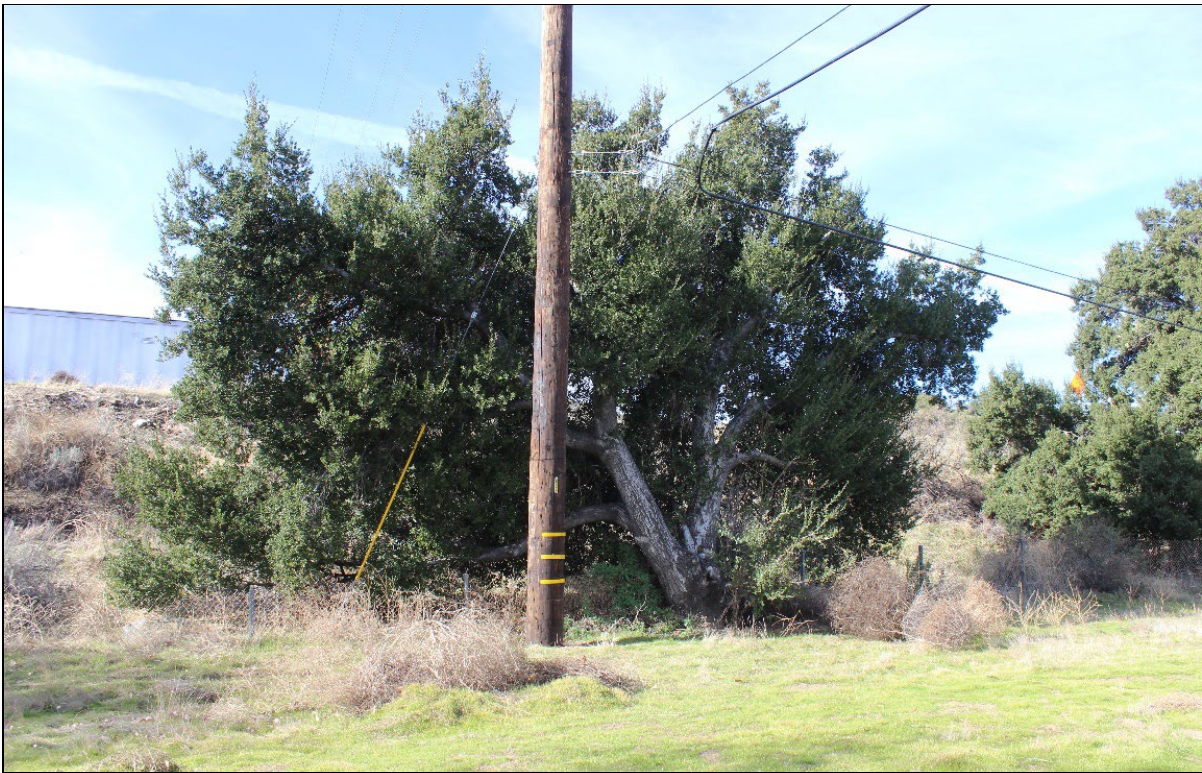
In general, the overall physical condition of the oak trees was consistent with that of trees found within urban areas. Trees 458 and 459 have been improperly pruned for utility or property clearance, reducing the overall balance or health ratings. Tree 459 is not located within the project site and has been subject to minor pruning. Barrels of potentially hazardous hydraulic oil previously observed in the vicinity of two oak trees (Trees 453 and 454) have subsequently been removed since the initial site visit. Tree 453 also has a pronounced lean, but this is not out of the ordinary for coast live oak trees.

Photograph 9: Coast live oak tree 458, facing west. Note lopsided canopy due to utility line clearance.
