**Compliance Biology, Western Spadefoot Toad Habitat Enhancement and
Monitoring Plan, Vista Canyon Project Site, Los Angeles County,
California (May 2009)**

**Western Spadefoot Toad Habitat Enhancement
and Monitoring Plan
Vista Canyon Project Site,
County of Los Angeles, California**

Western Spadefoot Toad Habitat Enhancement and Monitoring Plan Vista Canyon Project Site, Los Angeles County

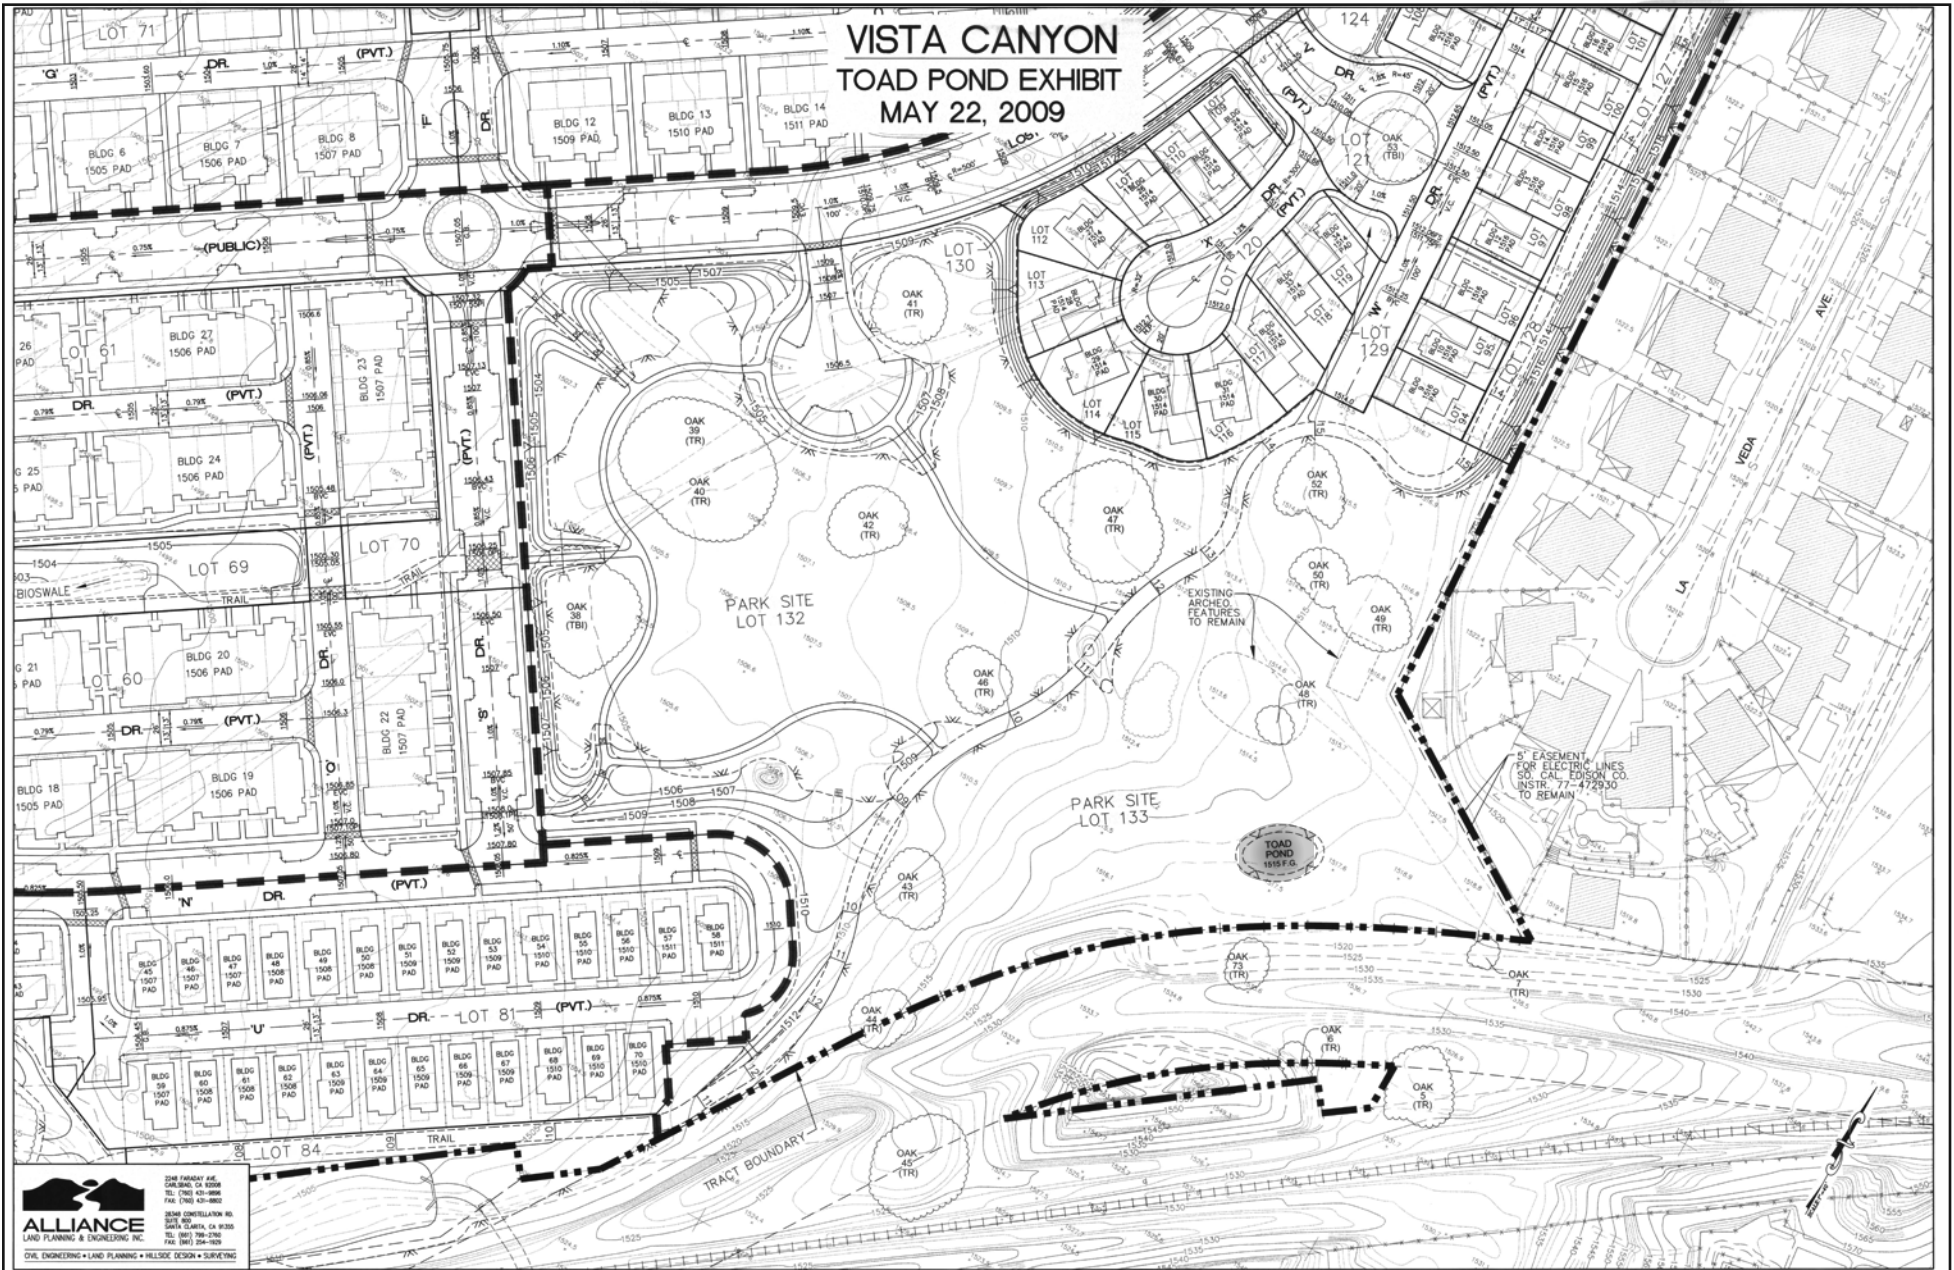
VISTA CANYON TOAD POND EXHIBIT MAY 22, 2009

Exhibit 2 illustrates the project site location for the proposed construction of the seasonal rainpool and associated upland habitat for the western spadefoot. The proposed site is suited for the creation of western spadefoot habitat, primarily because of its location and similarity of soils and vegetation to the existing on-site area where the spadefoot were observed.

The proposed site also was selected because of its proximity to naturally occurring resources suitable for western spadefoot. The pool would not be in the path of any direct drainage as such placement could result in too much water entering the pools and/or damage to the pools by flowing water. Naturally occurring occupied seasonal rainpools are typically located in open flat areas that are not fed by a stream or particular watershed. These natural pools are dependent upon sufficient rainfall to provide enough water in the pool.

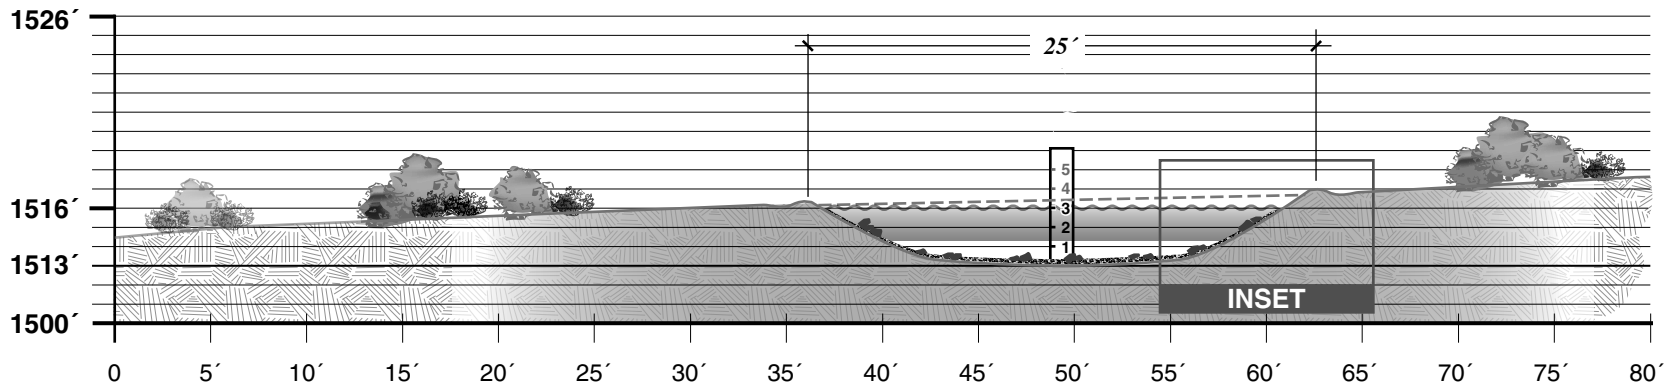
NORTH-SOUTH

scale v: 1" = 10' elevation
 h: 1" = 10' distance

Upon completion of excavation, the pool would be lined with a 15mil polyester mat that protects the pond liner from puncture. A 60mil Firestone EPDM pond liner (or two 45mil) would then be placed over the polyester mat and extend approximately two feet beyond the limits of the pond bank. The excess material would be buried around the perimeter of the pool. Two one-way valves would be installed in the bottom of the pool to vent out any gasses that may accumulate beneath the pool that could otherwise cause damage to the liner.

Upon installation of the pond liner, a one to two inch layer of ¼-inch or less pea gravel, mixed with native soil, would be placed over the entire surface of the liner to prevent exposure of the liner to direct sunlight. Larger rock would be randomly placed throughout the pool and around the perimeter to serve as stabilizing points for the pea gravel to prevent it from sloughing down to the bottom. This rock also would provide additional surface area for algae that would serve as food for tadpoles. A few scattered twigs would be placed within the pool to serve as substrate for oviposition.

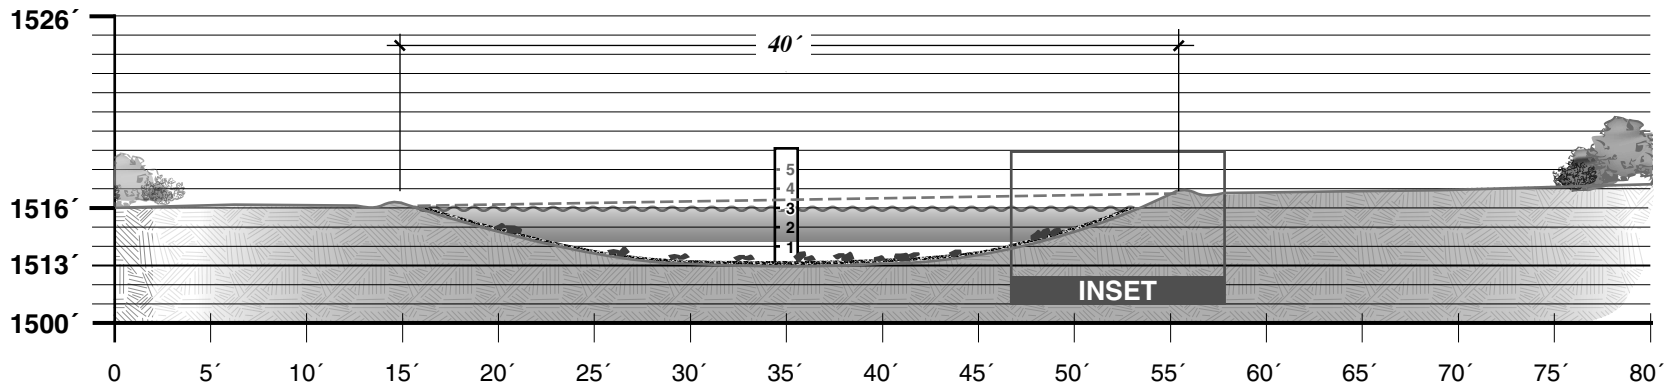
WEST-EAST

scale v: 1" = 10' elevation
 h: 1" = 10' distance

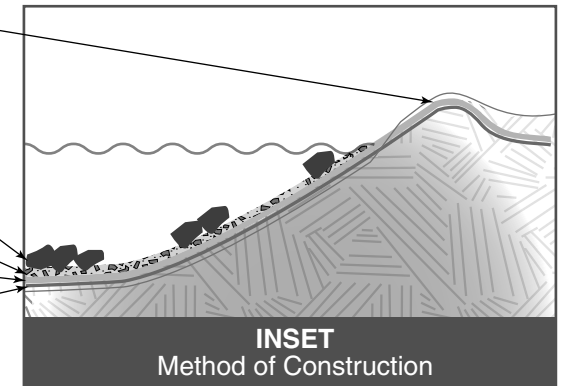
POLYESTER AND EPDM ANCHORED BY BURIAL

- STABILIZING ROCK LAYER
- PEA GRAVEL/SOIL LAYER
- EPDM POND LINER
- POLYESTER MAT

The proposed pond design would utilize a liner material that is guaranteed for at least 25 years with direct UV exposure. The planned design would cover the liner material with a gravel/soil mixture that protects the surface and minimizes UV exposure. In such cases, the liner is expected to last in excess of 50 years. In addition, sediment material is anticipated to be deposited in the ponds over time as a result of normal rainfall runoff and wind blown dust deposits. This sediment would serve to further protect the liner without significantly diminishing the pond storage capacity.

If portions of the liner were constantly exposed to UV light, potential failure might occur 25-30 years after installation. During this time frame, it is expected that the underlying soils will consolidate and minimize potential losses of water due to infiltration. Also, during this time period, the ponds would become “naturalized” through the natural deposition of soils and development of vegetation from seeds deposited in and adjacent to the ponds by animals and wind. This “naturalization” process would further assist in providing a base condition within the pond that would minimize the potential for infiltration losses.

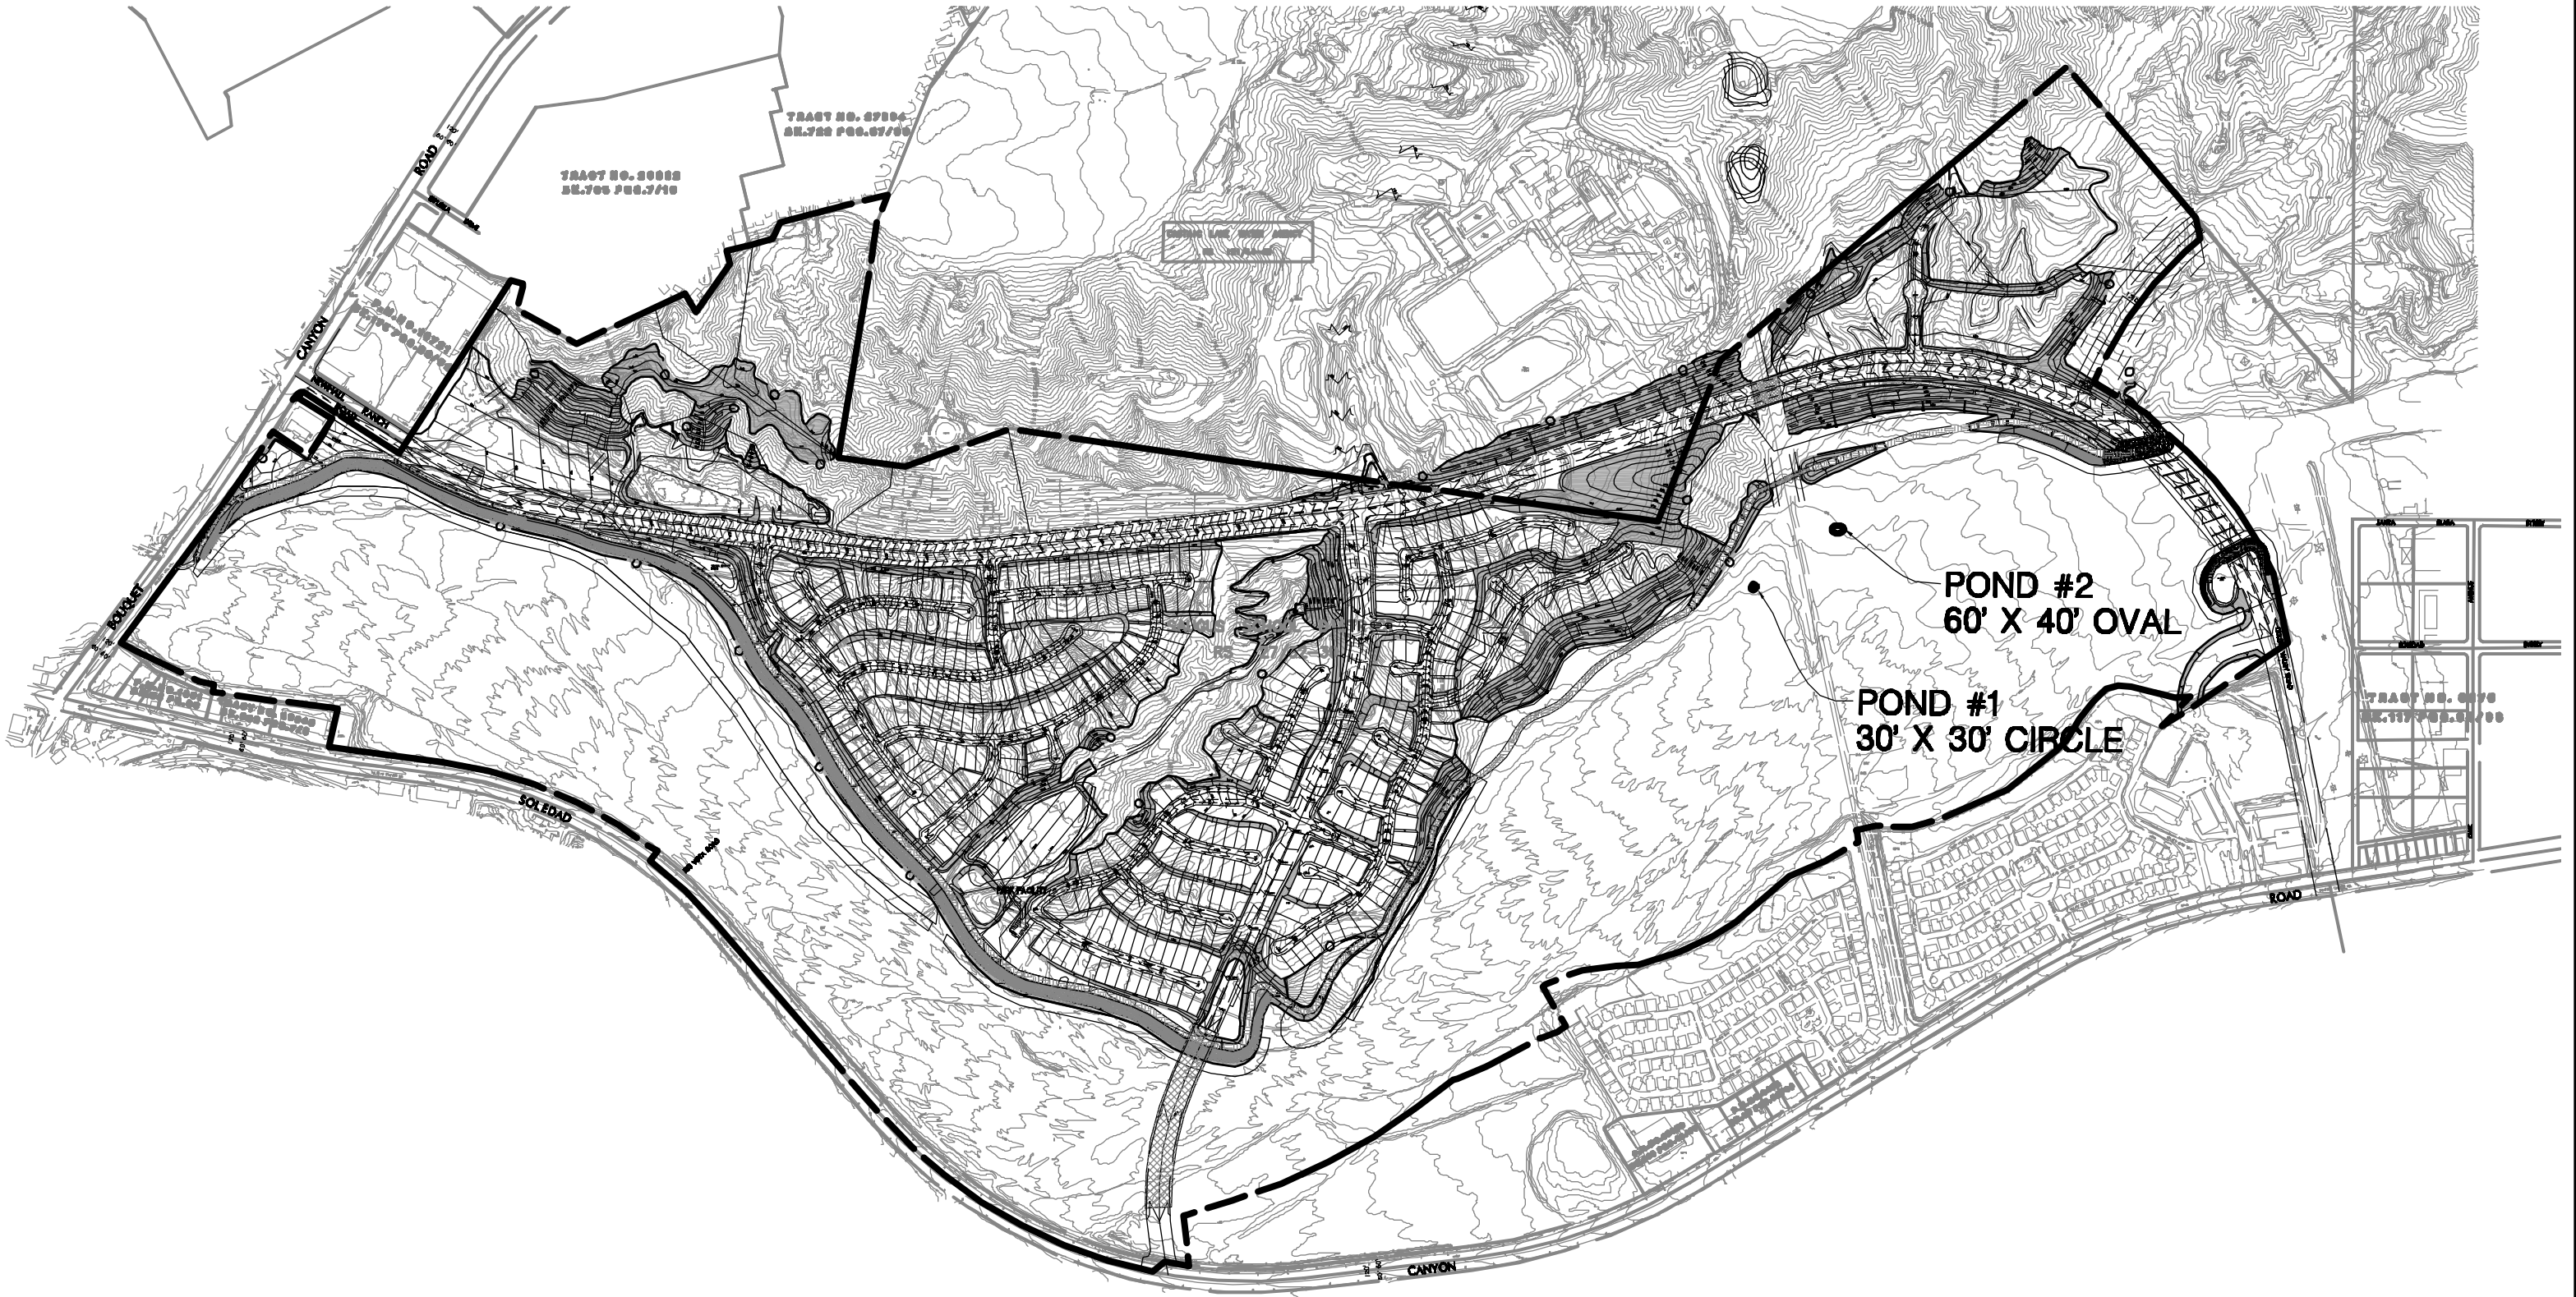
RIVER PARK
EXHIBIT 2
MITIGATION POND LOCATIONS

Exhibit 2 illustrates locations on the River Village project site selected for construction of the two seasonal rainpools. These locations were selected based on the availability of open space and the proximity of naturally occurring resources suitable to support western spadefoot toads. These locations were approved by CDFG. The pools were not placed in the path of any direct drainage as such placement would result in too much water entering the pools and/or damage to the pools by flowing water.

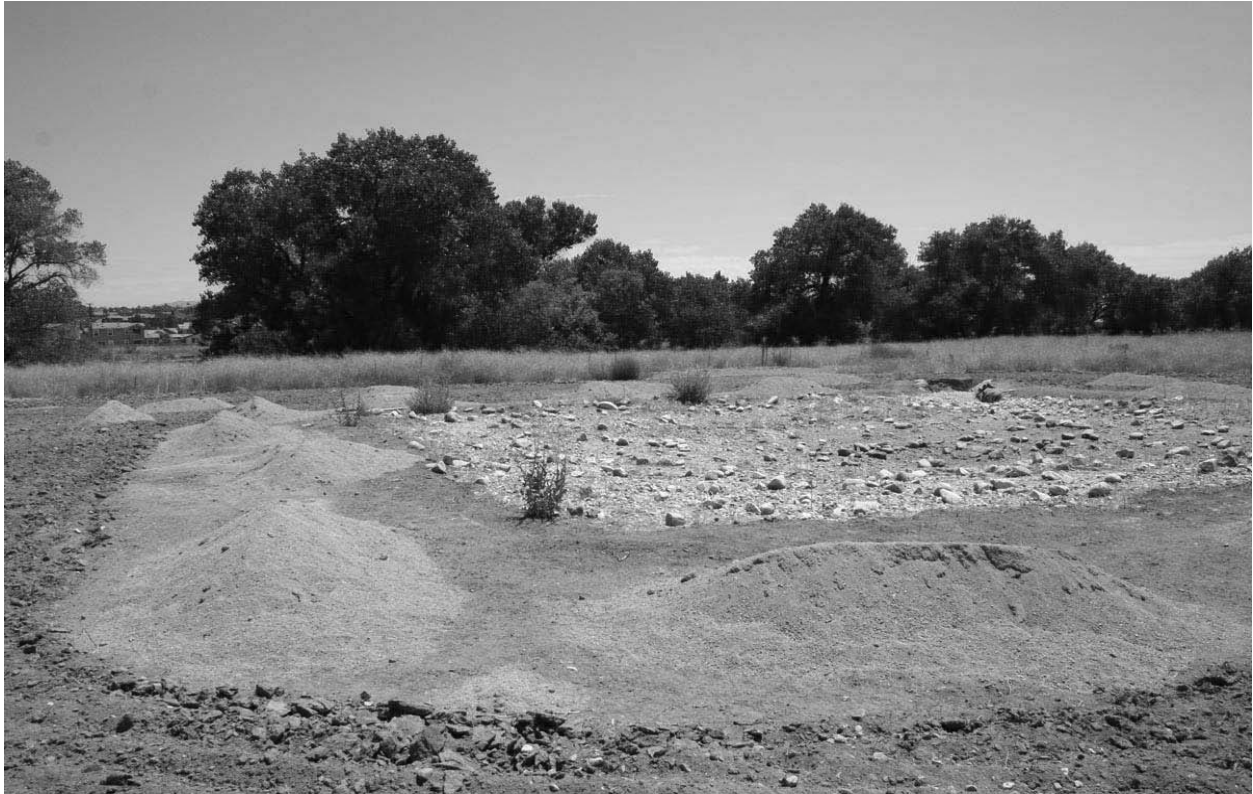
Photo 1 – View of completed Pool 1 with San Francisquito Creek in background.

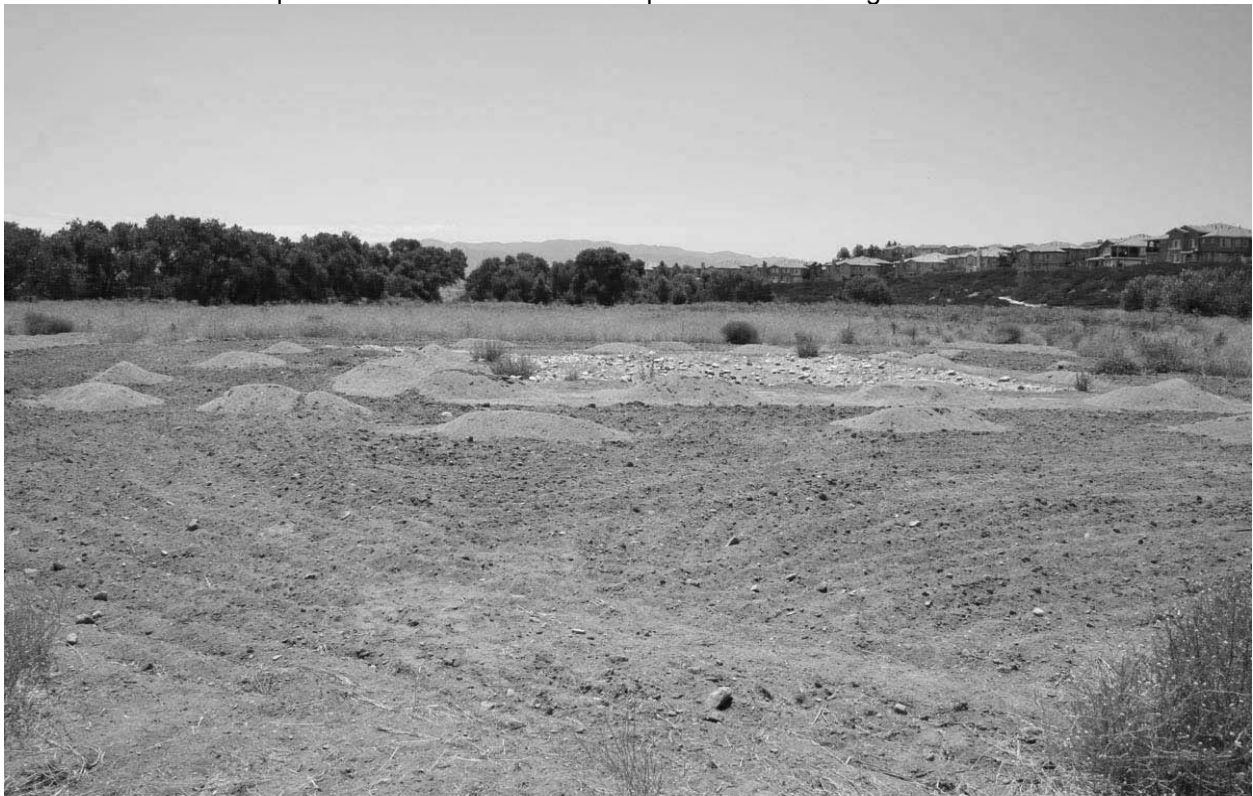
Photo 2 – View southeast of Pool 1 illustrating surrounding sand piles for burrowing substrate.

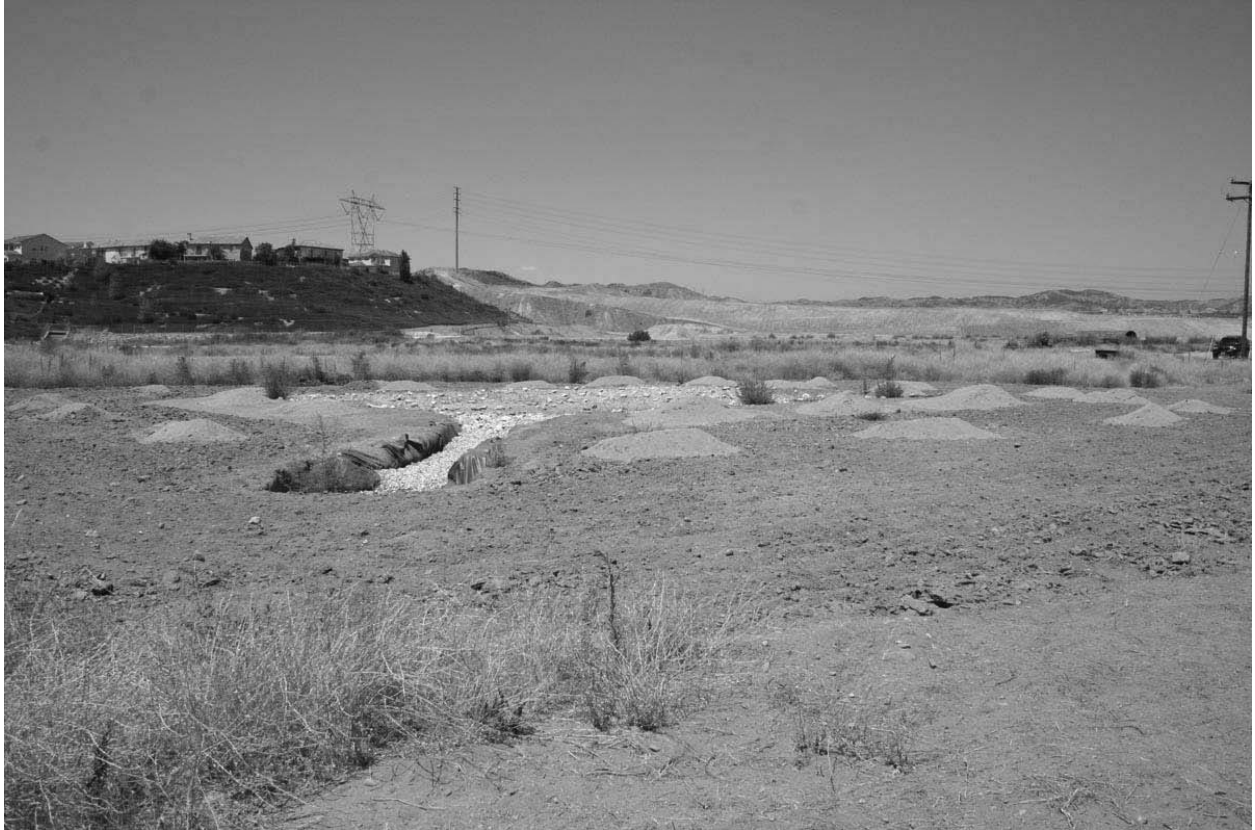
Photo 3 – View west of Pool 1 illustrating small overflow channel.

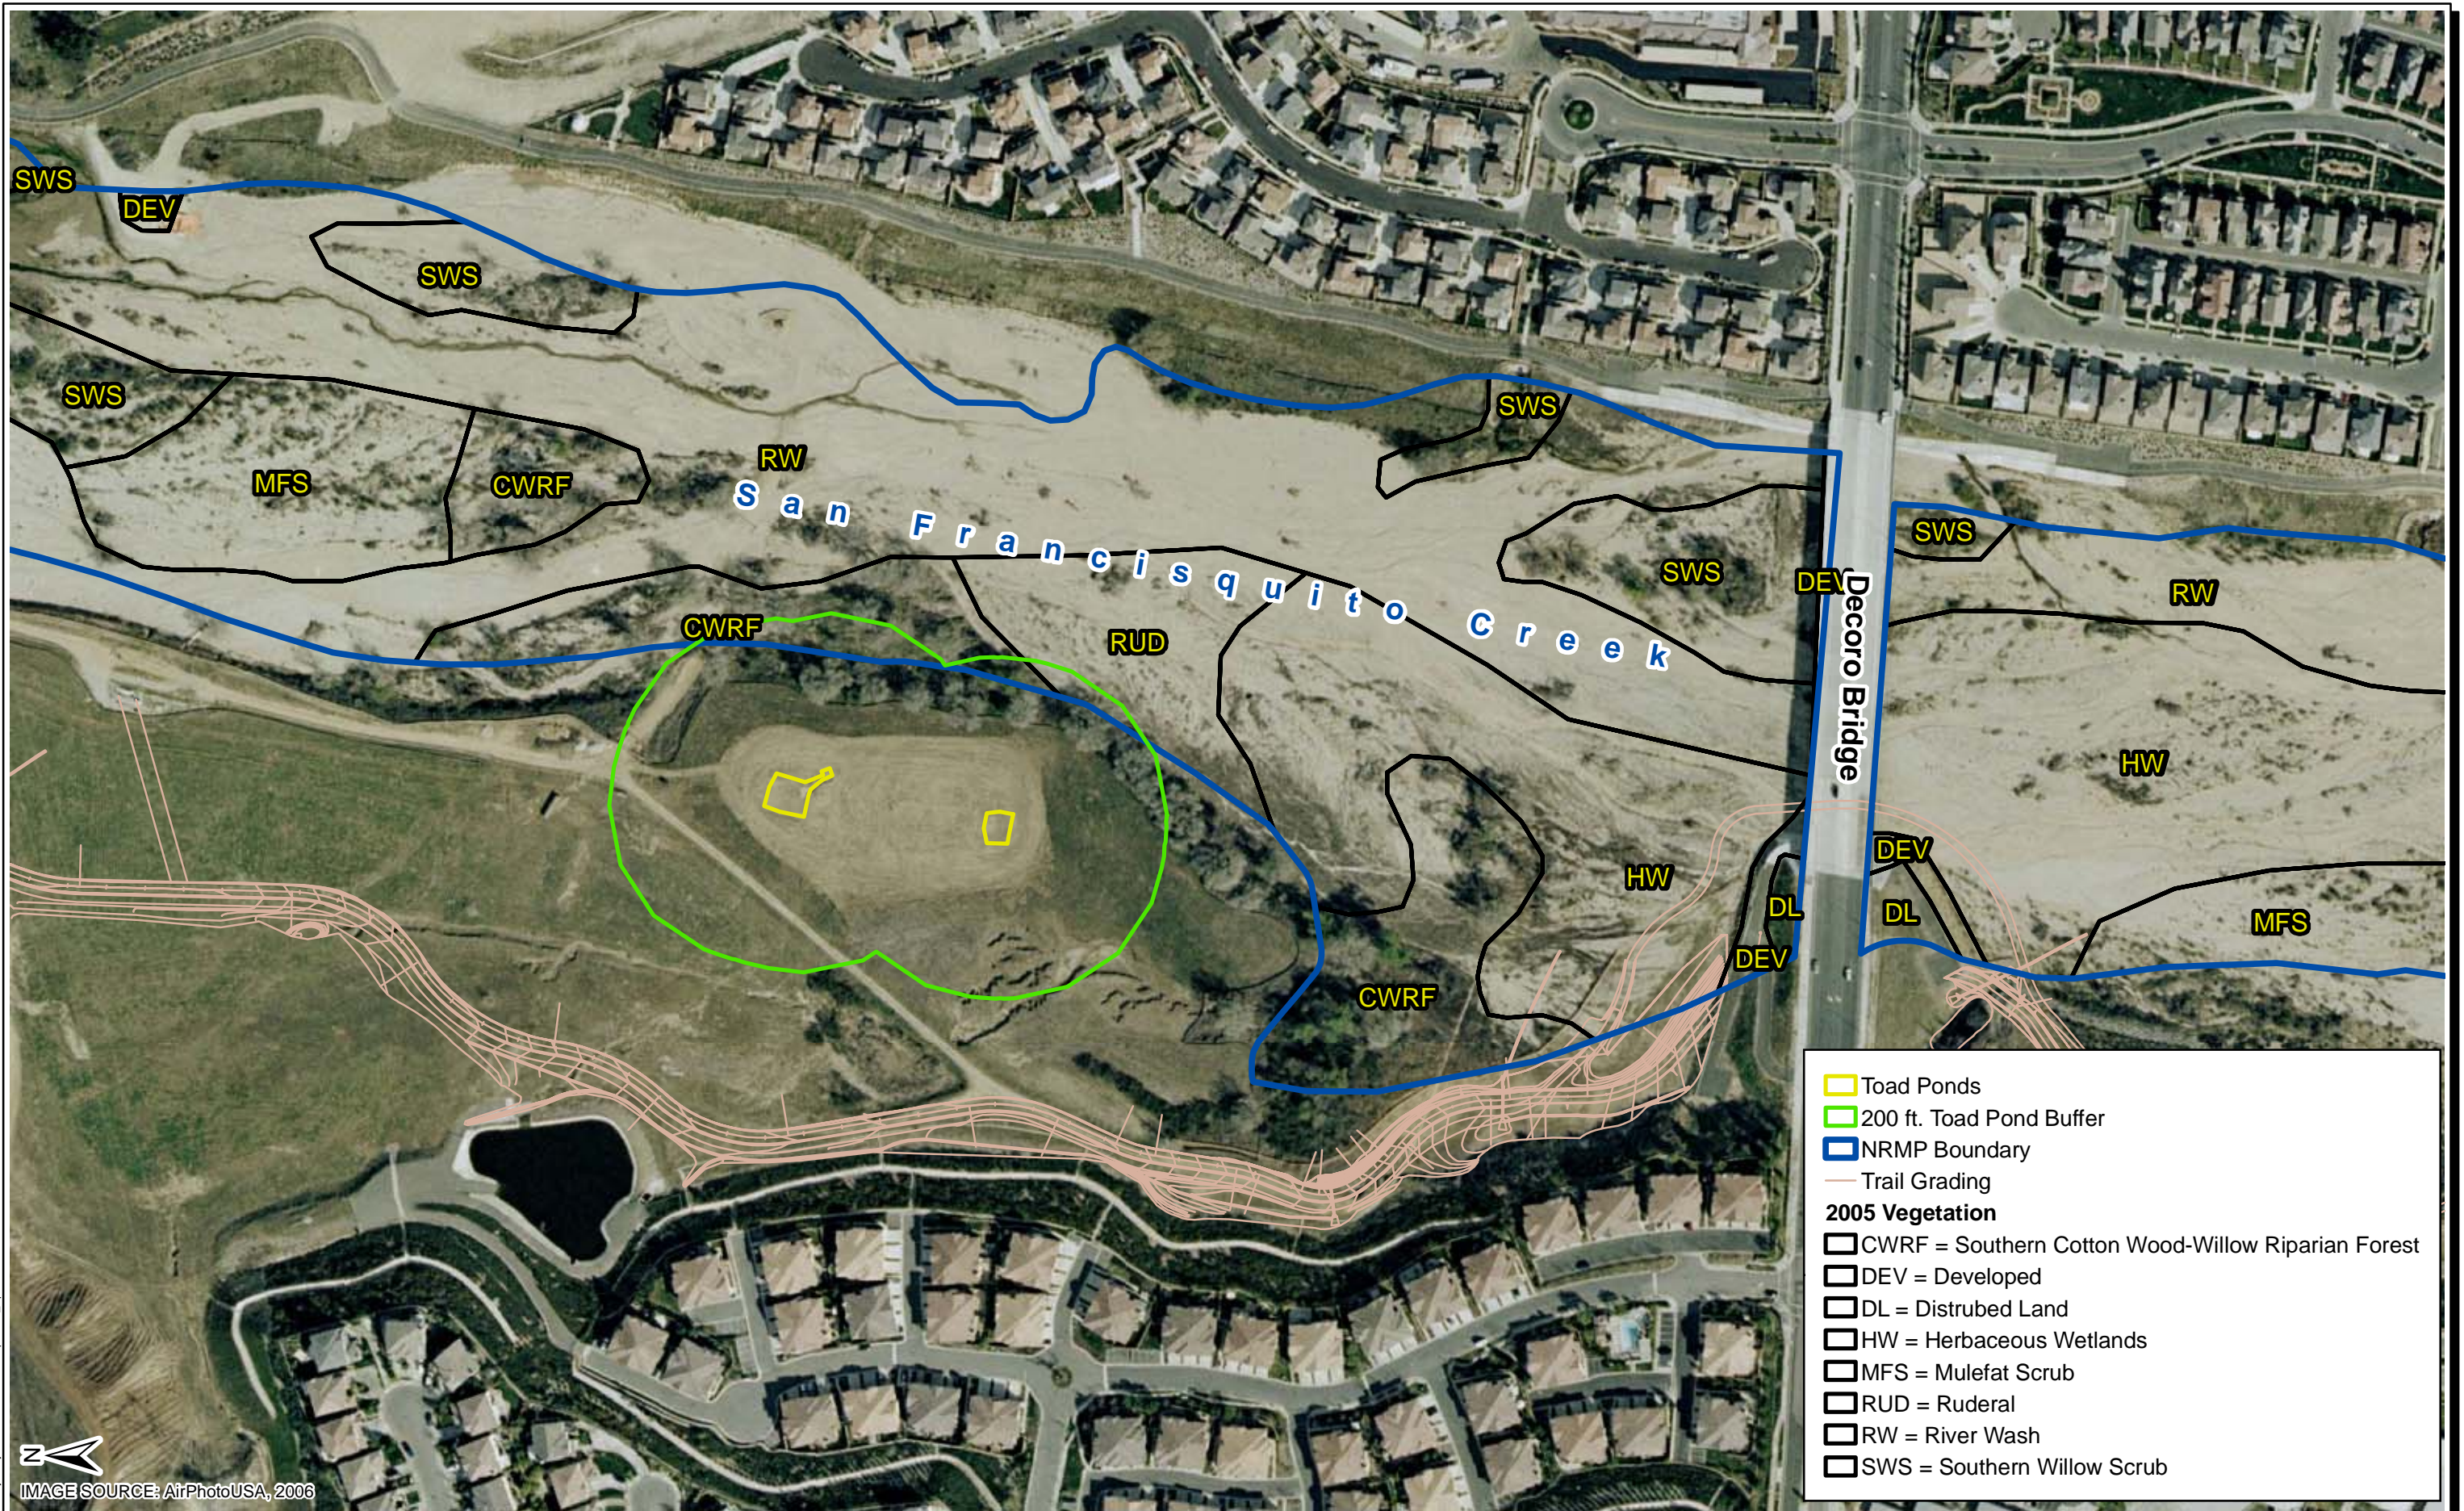
Exhibit 2 illustrates the seasonal rainpool locations on the West Creek project site. These locations were selected based on the availability of open space and the proximity of naturally occurring resources suitable to support western spadefoot toads. The selected locations were approved by CDFG and the County. The pools were not placed in the path of any direct drainage as such placement would result in too much water entering the pools and/or damage to the pools by flowing water. Prior to construction of the pools, an approximately 150 radius was scraped clear of all vegetation around each site. As the vegetation was predominantly non-native, it was removed from the site.

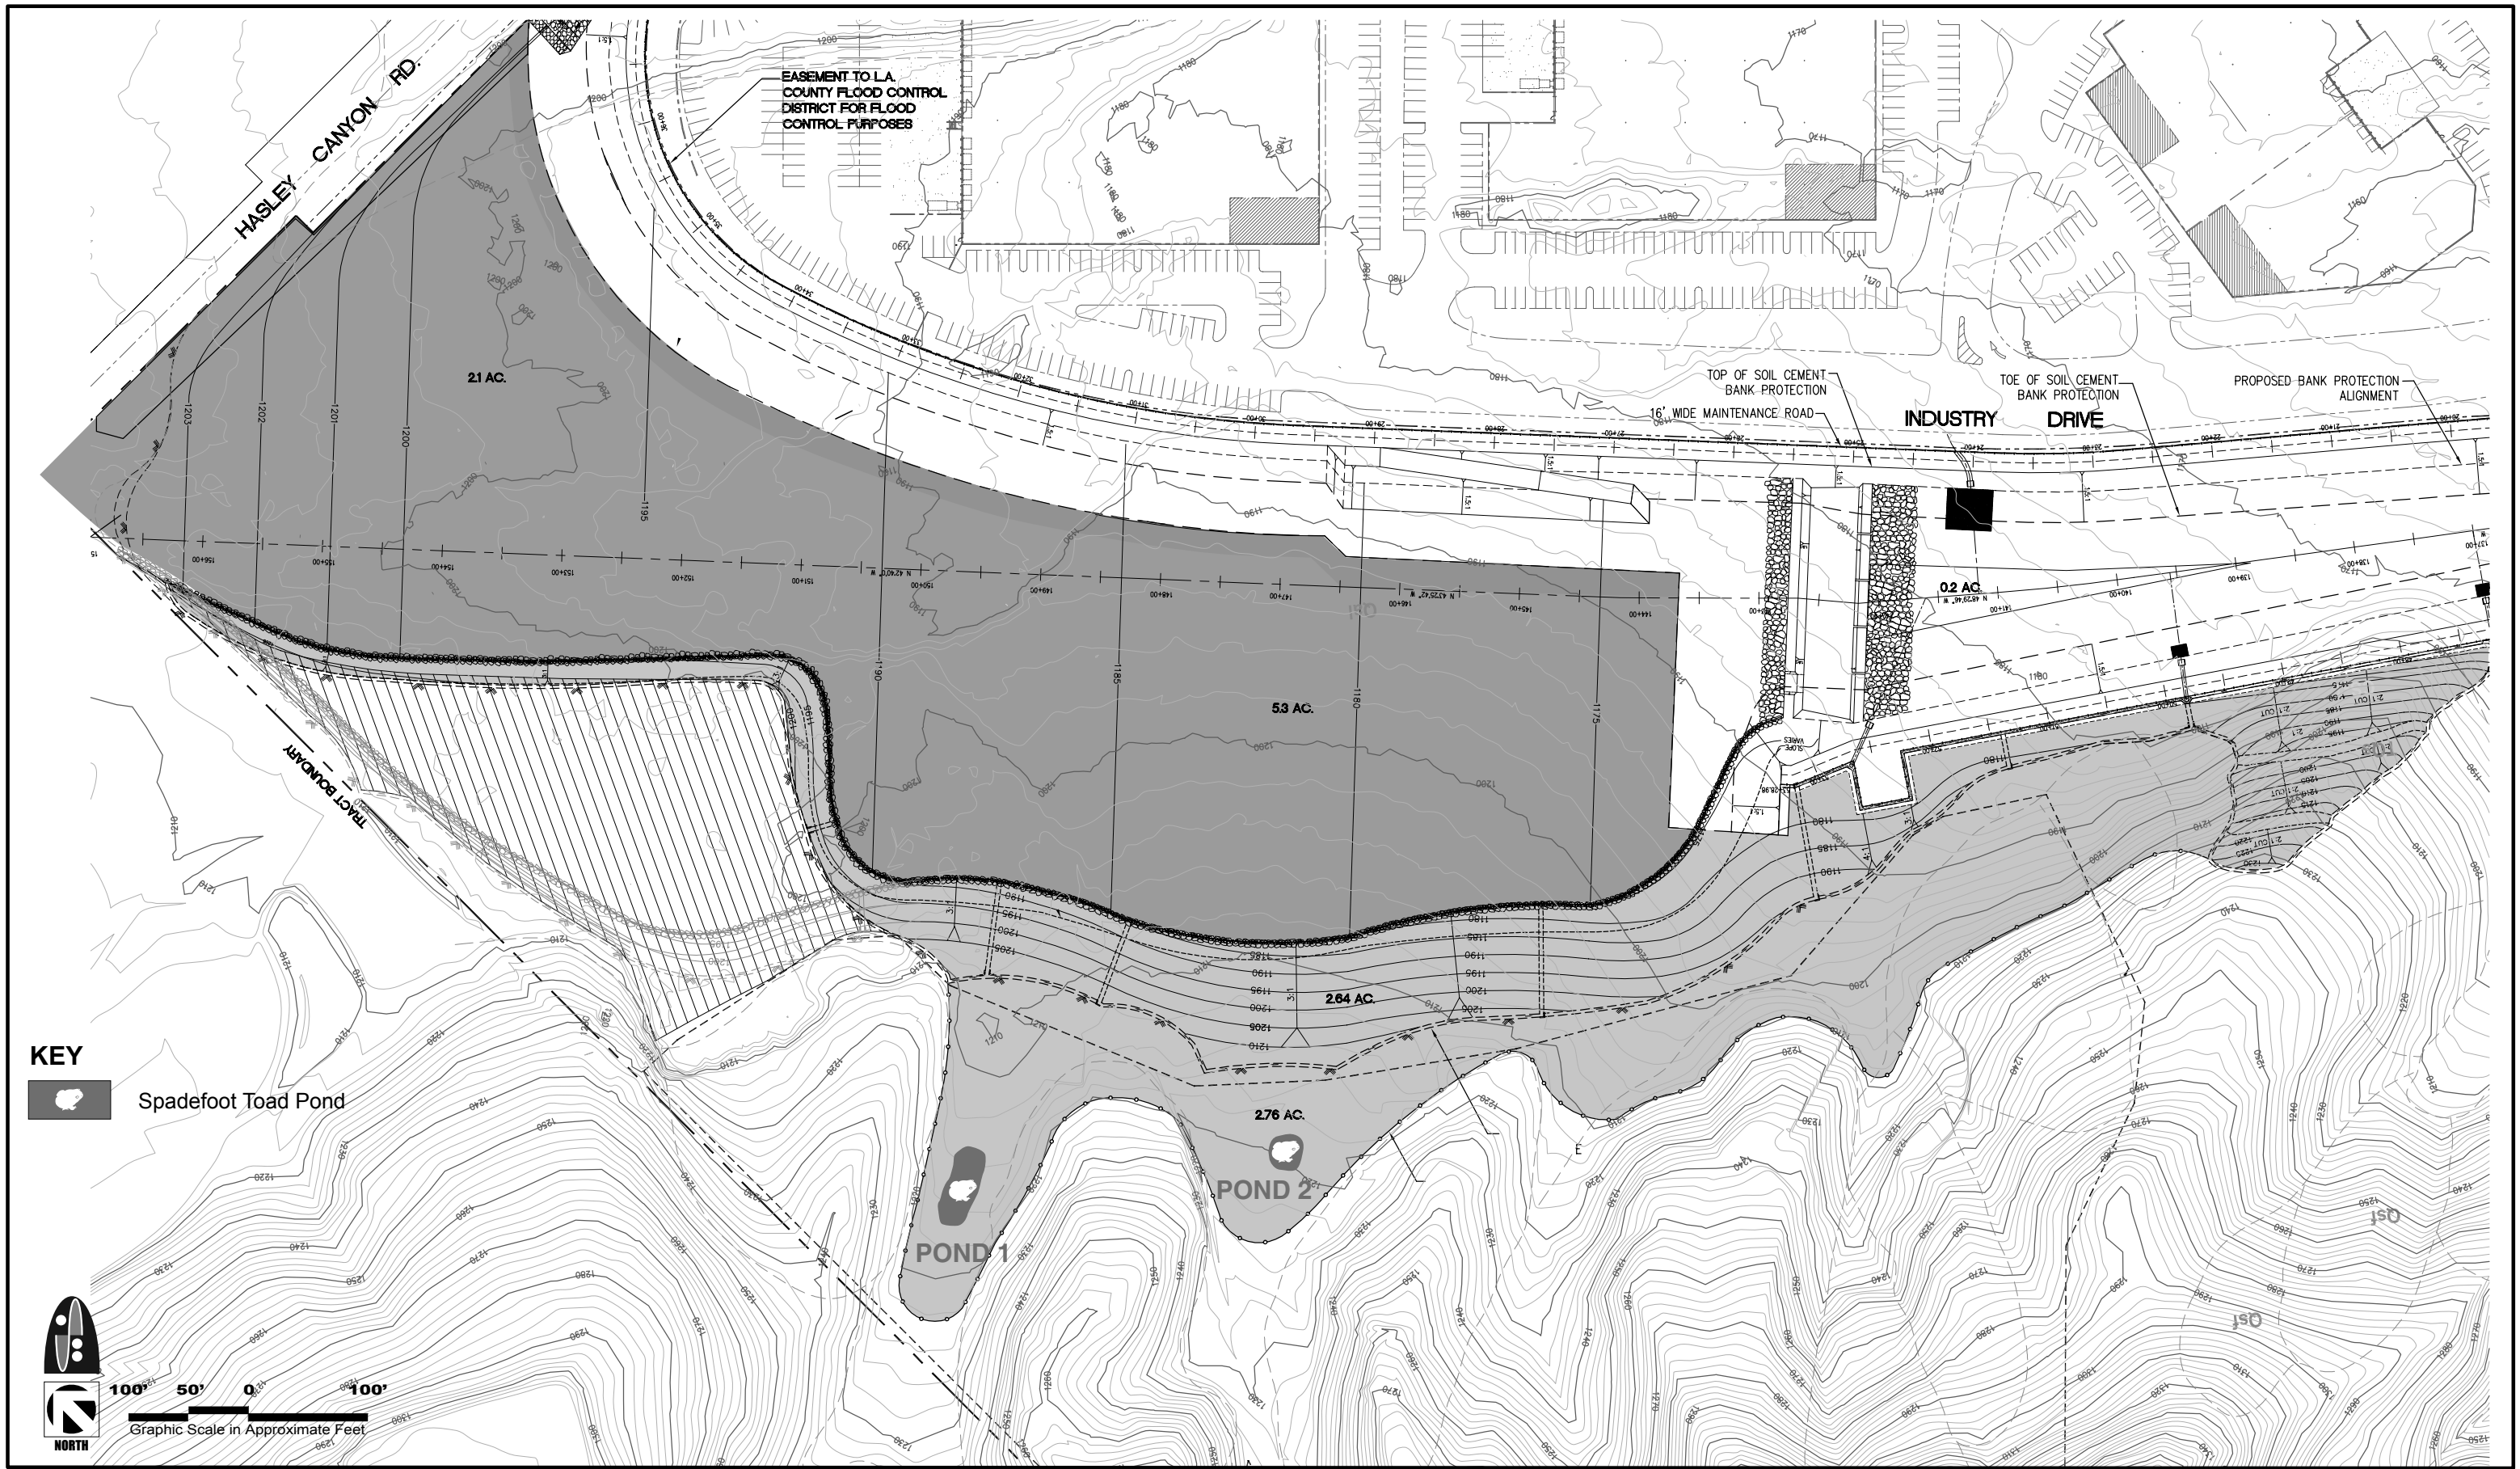
Exhibit 2 illustrates the manufactured seasonal rainpool locations on the Commerce Center project site. These locations were selected based on the availability of open space, topography and the proximity of naturally occurring resources suitable to support western spadefoot toads. Additionally, this restoration and enhancement plan has been tied in to the Hasley Creek Restoration plan, in as much as the restorative planting for both projects will be incorporated together. The selected locations were approved by CDFG and the County. The pools were not placed in the path of any direct drainage as such placement would result in too much water entering the pools and/or damage to the pools by

flowing water. Prior to construction of the pools, an approximately 100-foot radius was scraped clear of all vegetation around each site. Non-native vegetation cut was removed from the site and native scrub removed was mulched and stored on site for future use.
