Via Princessa Park Project

Biological Technical Report

November 8, 2023 | 03100.00012.001

City of Santa Clarita
23920 Valencia Boulevard
Santa Clarita, CA 91355

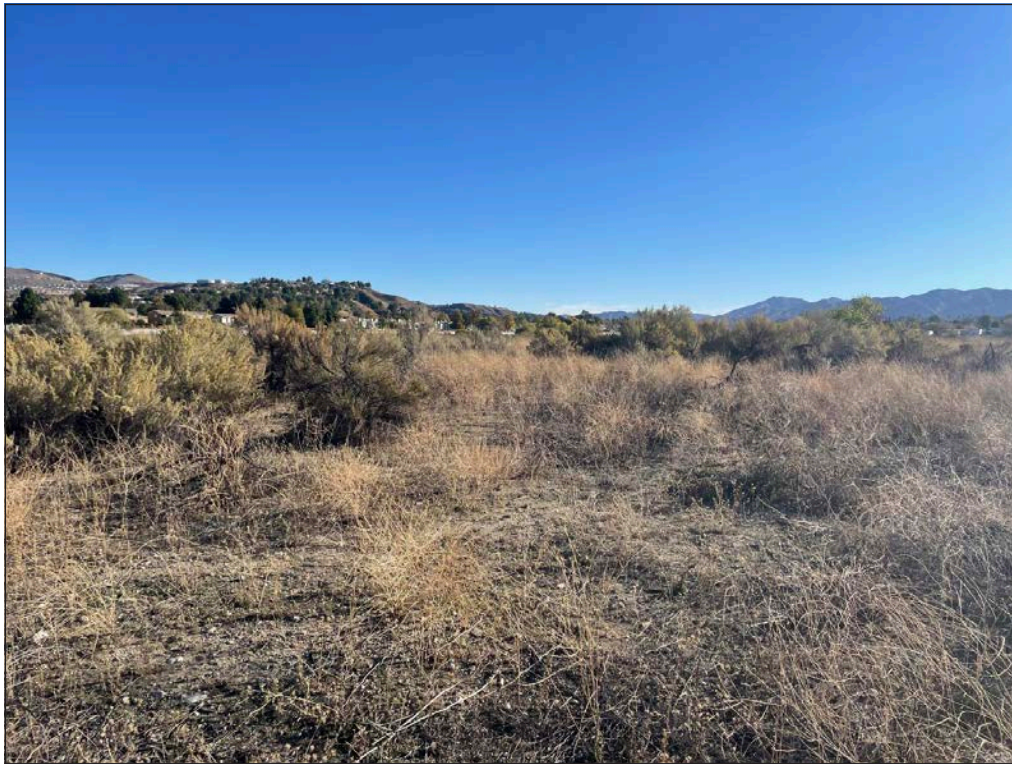
Upland mustard fields/rubber rabbitbrush scrub was observed in the northwestern portion of the project site, totaling 1.49 acres. This plant community was dominated by short-pod mustard, with rubber rabbitbrush scattered throughout. Understory species consisted of non-native common Mediterranean grass and short-pod mustard.

Photo 1: View of upland mustard fields/rubber rabbitbrush scrub in the western portion of the project site, facing southwest. Photograph taken on November 15, 2022.

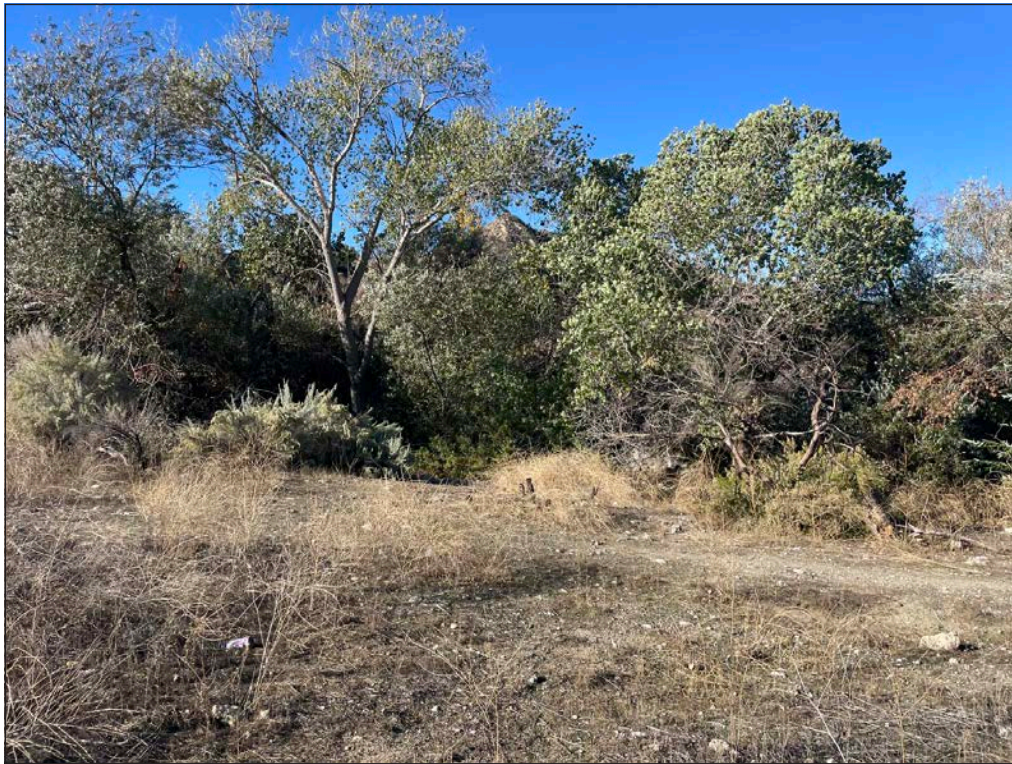
Fremont cottonwood forest and woodland was observed within Honby Channel, totaling 0.46 acre. This community was dominated by Fremont cottonwood with arroyo willow (*Salix lasiolepis*) present as a subdominant species. Scattered tree-of-heaven was also noted. The understory was mostly unvegetated due to severe scouring. Non-native species observed included common Mediterranean grass (*Schismus barbatus*), giant reed (*Arundo donax*), saltcedar (*Tamarix ramosissima*), and short-pod mustard.

Photo 3: View of Fremont cottonwood forest and woodland within Honby Channel in the central portion of the project site, facing west. Photograph taken on November 15, 2022.

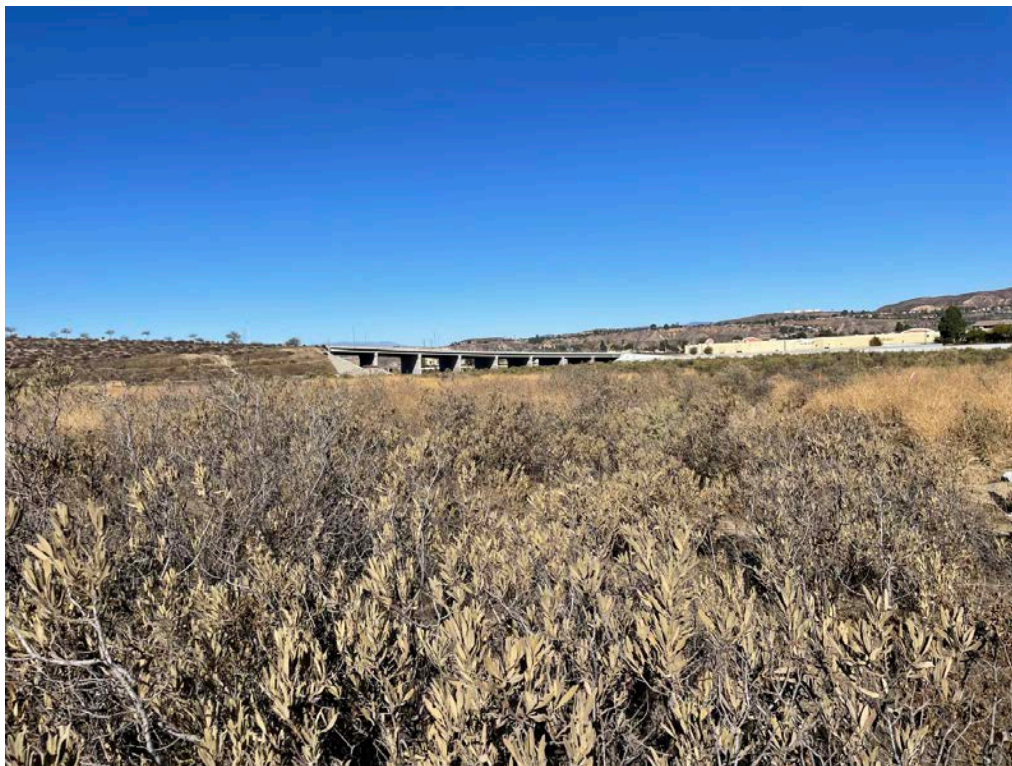
Yerba santa scrub was observed south of Tributary A in the central portion of the project site, totaling 0.41 acre. This plant community was dominated by thicket yerba santa with other scattered native species, including big basin sagebrush, rod wirelettuce (*Stephanomeria virgata*), and slender buckwheat (*Eriogonum gracile*).

Photo 4: View of the yerba santa scrub in the central portion of the project site, facing northwest. Photograph taken on November 15, 2022.

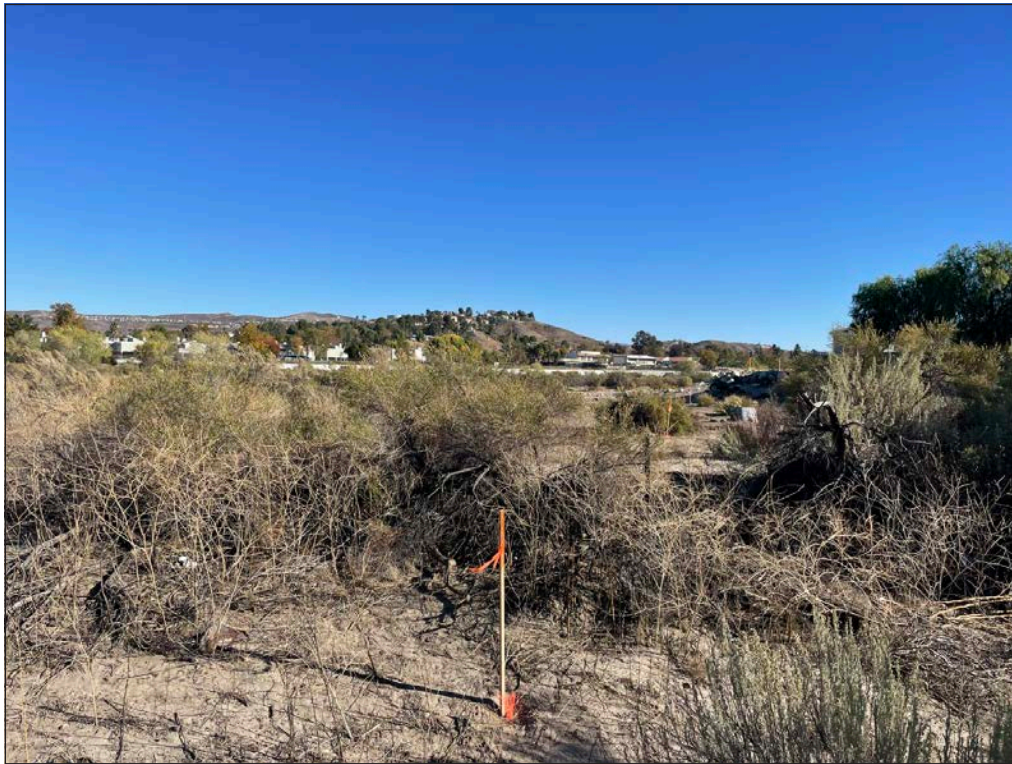
Photo 5: View of the scale broom scrub in the northeastern portion of the project site, facing northeast. Photograph taken on November 15, 2022.

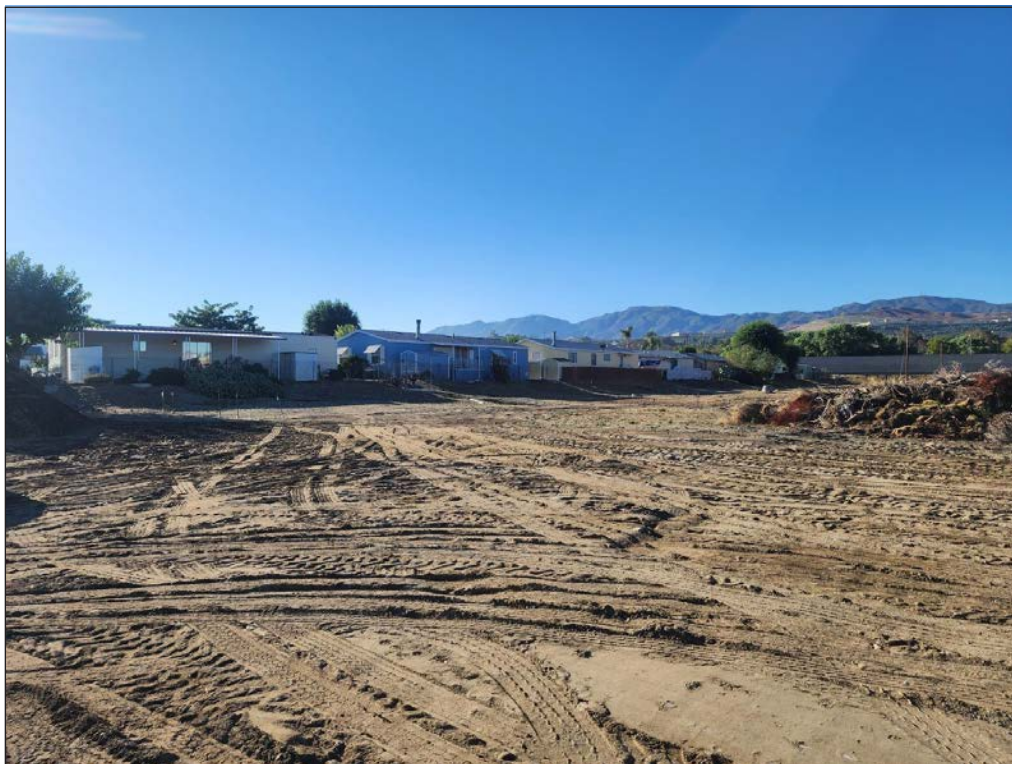
Disturbed habitat was observed throughout the project site, totaling 6.17 acres. These areas were mostly concentrated around the periphery of the southern and eastern portions of the project site. There is an area in the northeastern corner of the project site that is within the active construction zone of the Los Angeles County Sanitation District's Soledad Canyon Relief Trunk Sewer Section 4 Project.

Photo 6: View of disturbed habitat in the northeastern portion of the project site, facing southeast. Photograph taken on August 25, 2023.

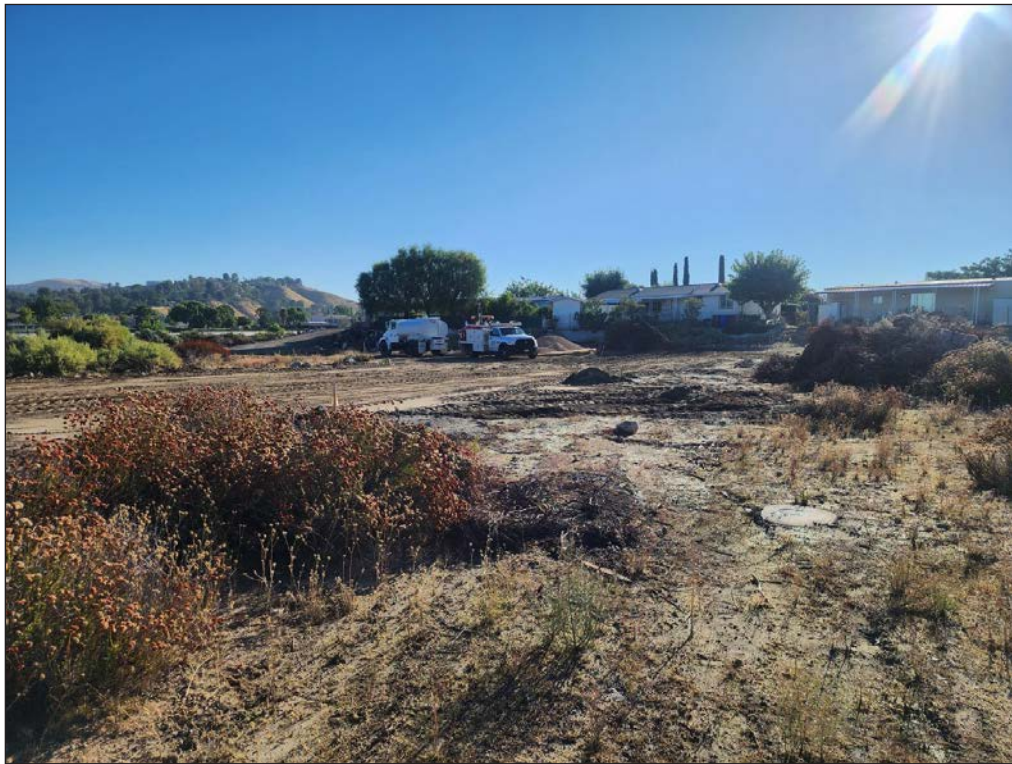
Disturbed/California buckwheat scrub was observed in the northeastern portion of the project site, totaling 0.20 acre. This community consisted of sparse California buckwheat.

Photo 7: View of the disturbed/California buckwheat scrub in the northeast portion of the project site, facing northeast. Photograph taken on August 25, 2023.

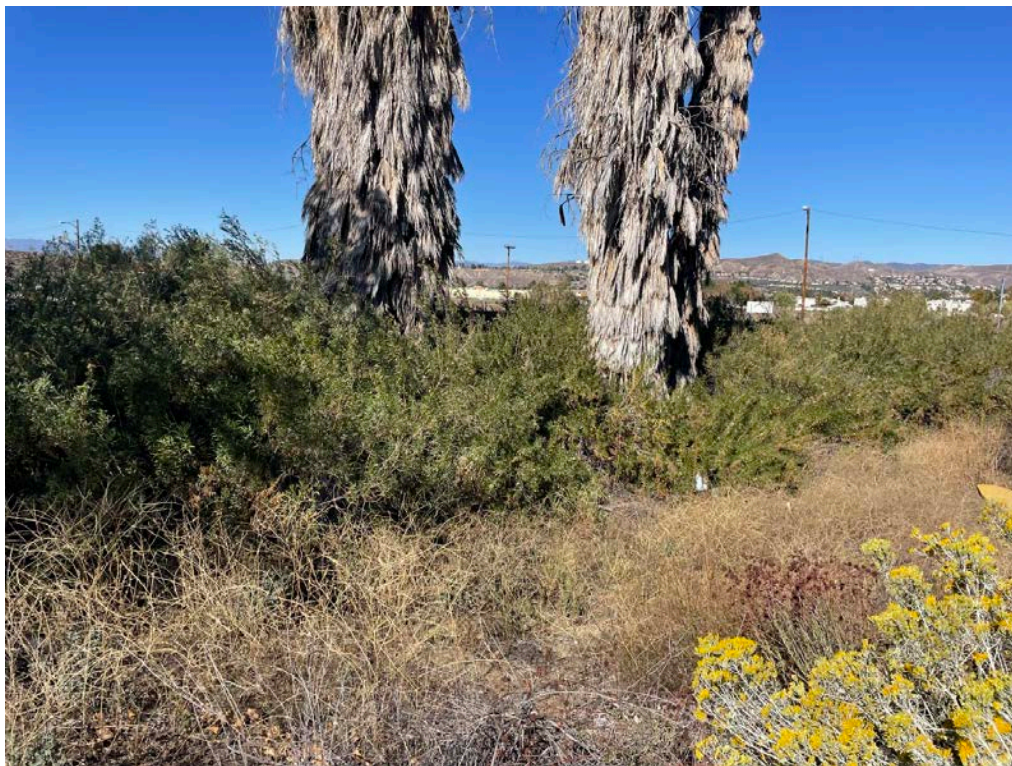
Mule fat thickets totaled 0.42 acre and was observed within Honby Channel, Drainage A, and Tributary A1. Mule fat thicket was dominated by mule fat with scattered black willow (*Salix gooddingii*), coyote brush, and black sage (*Salvia mellifera*). Large Mexican fan palms (*Washingtonia robusta*) were observed within Drainage A as well.

Photo 8: View of the mule fat thickets within Drainage A in the southeast portion of the project site, facing north. Photograph taken on November 15, 2022.

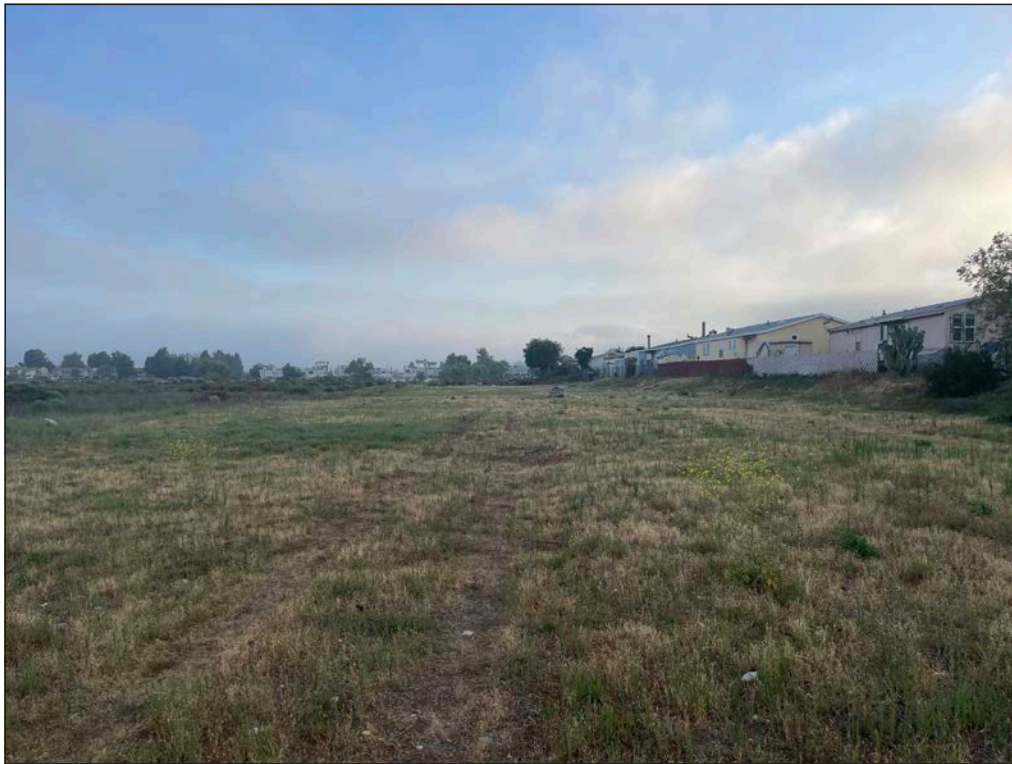
Photo 1: View of the disturbed habitat along the eastern project boundary, facing north.

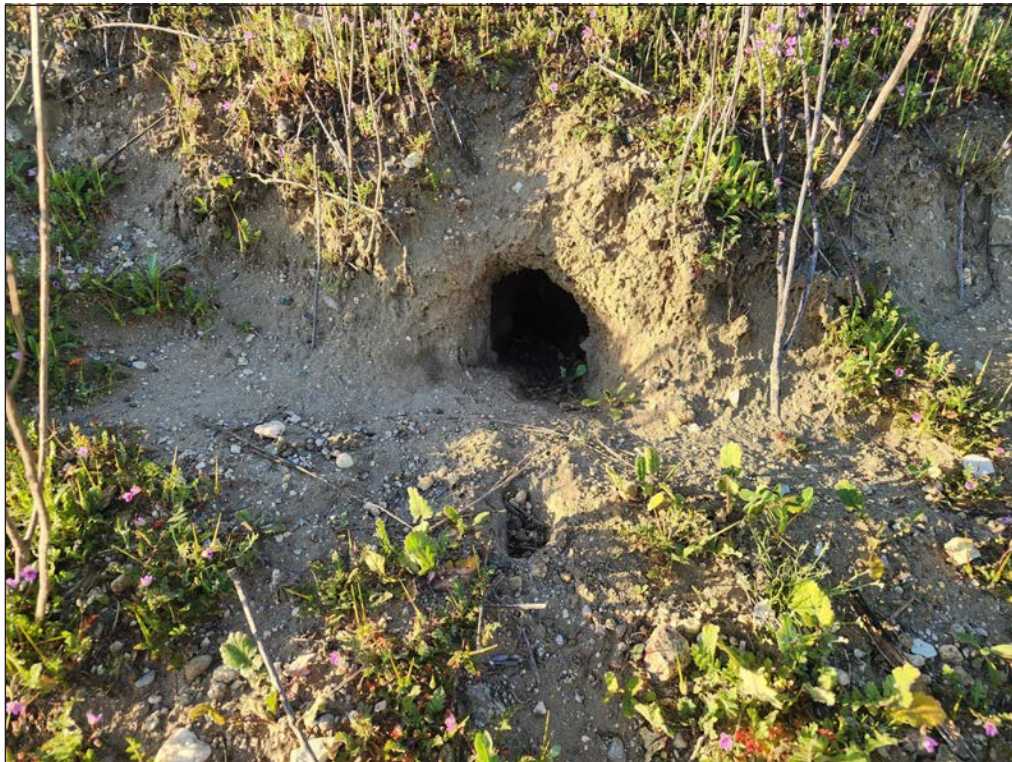
Photo 2: View of an earthen burrow in the north-central portion of the project site.

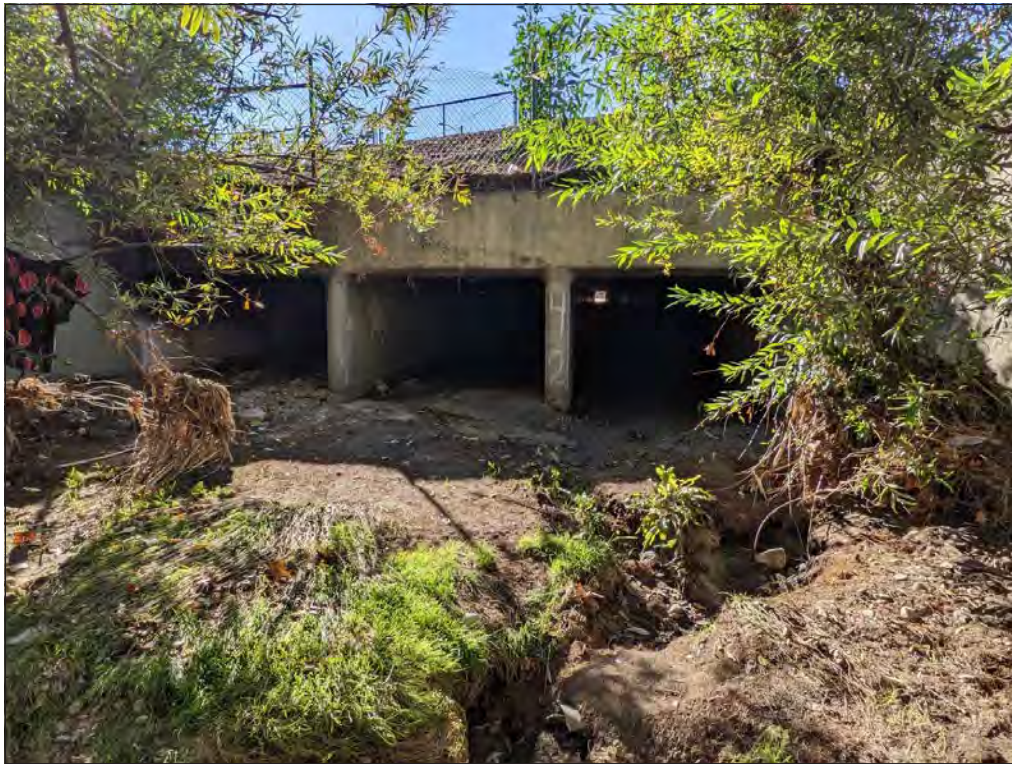
Photo 1: View of the upstream portion of Honby Channel, facing south. Sediment accumulation and erosional issues can be seen.

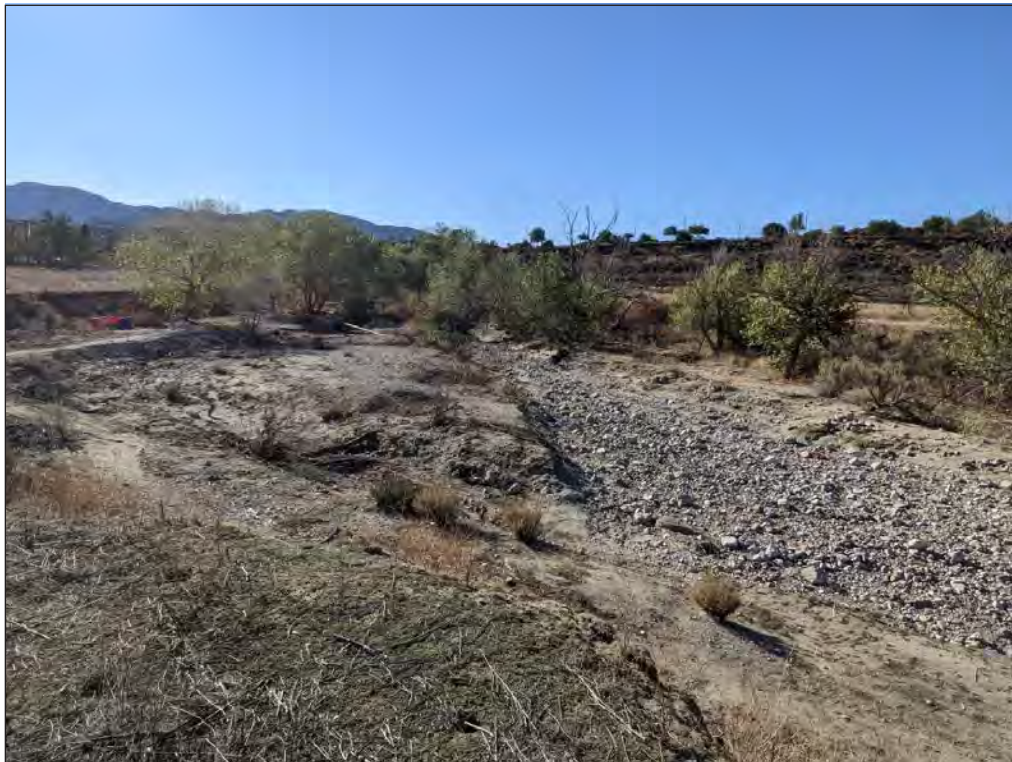
Photo 2: View of the middle portion of Honby Channel, facing southeast.

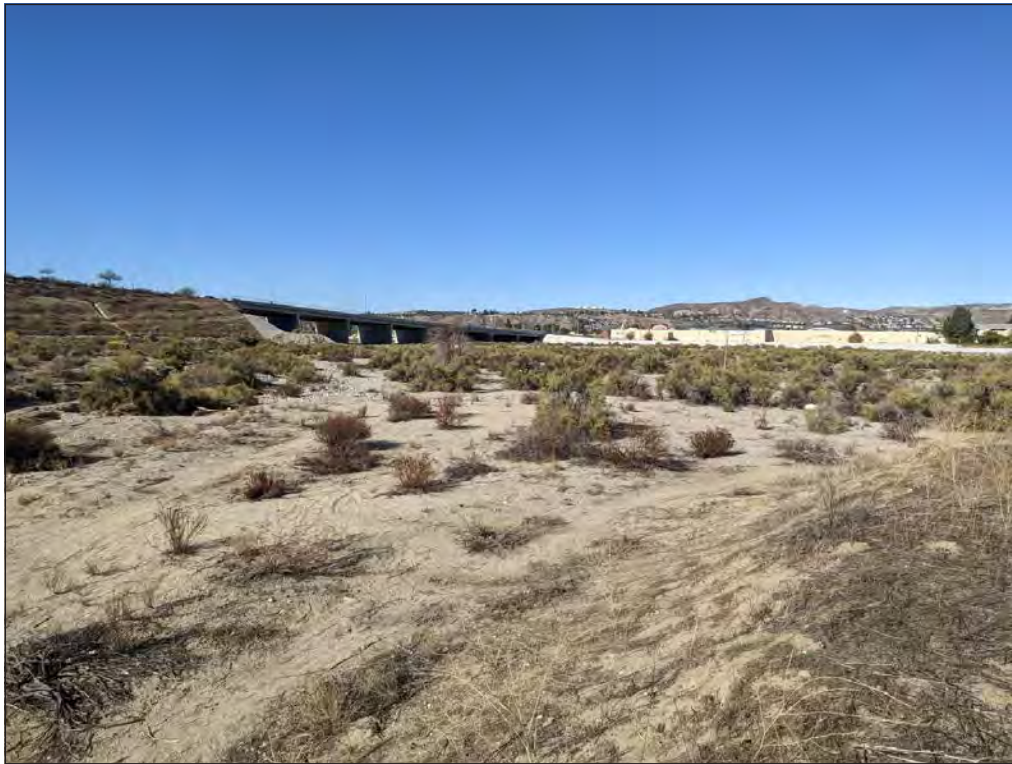
Photo 3: View of the downstream portion of Honby Channel where it connects to the Santa Clara River, facing northwest.

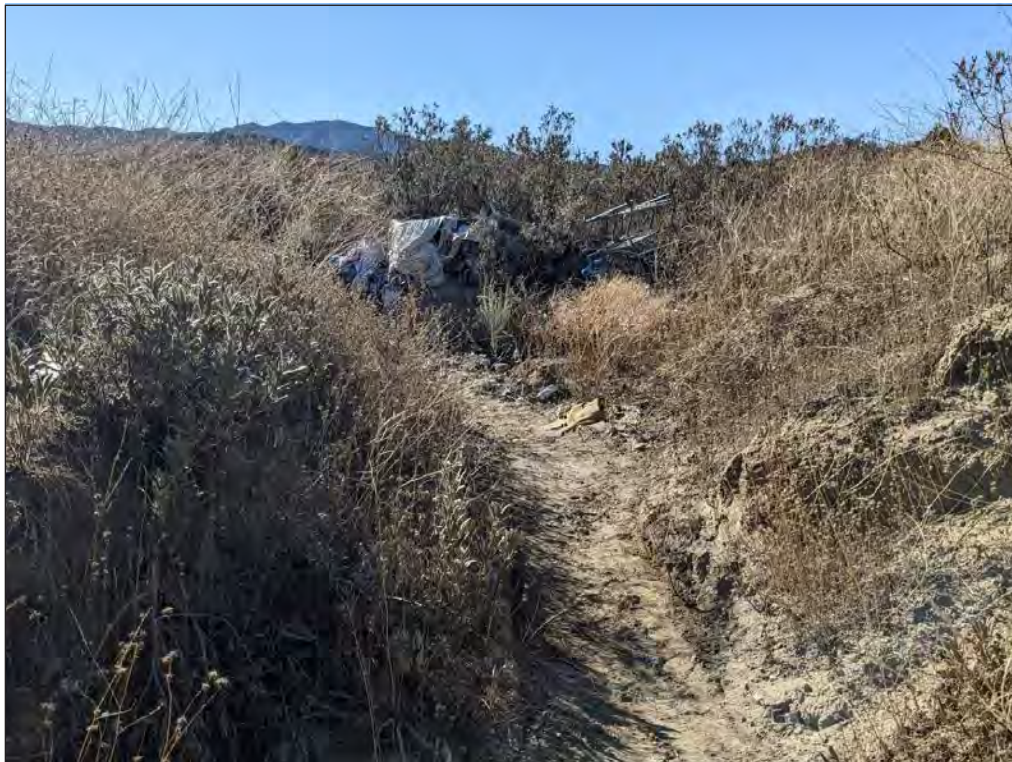
Photo 4: View of Tributary A, facing north.

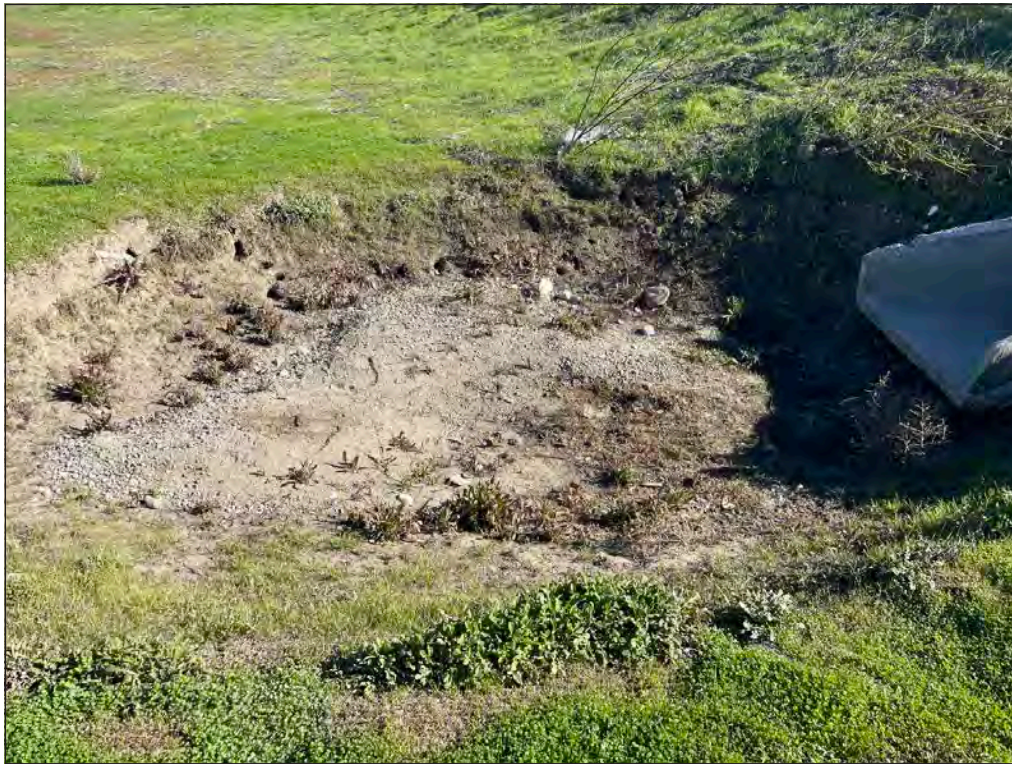
Photo 5: View of the downstream terminus of Drainage A, facing east.

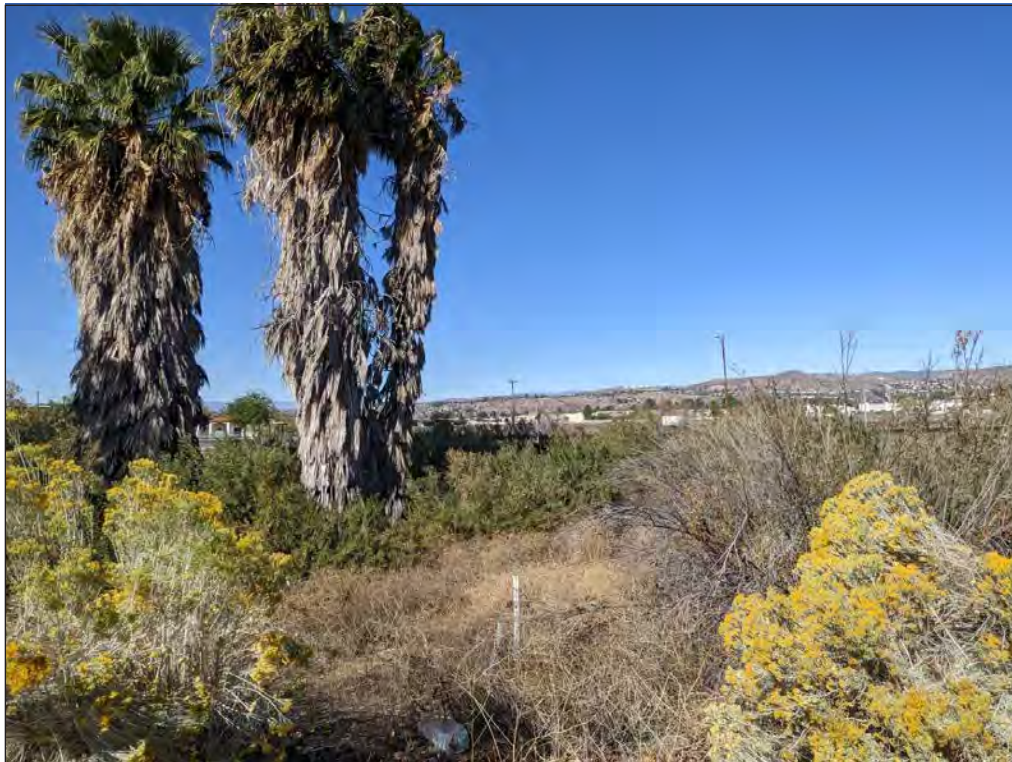
Photo 6: View of the upstream portion of Drainage A, facing northwest.

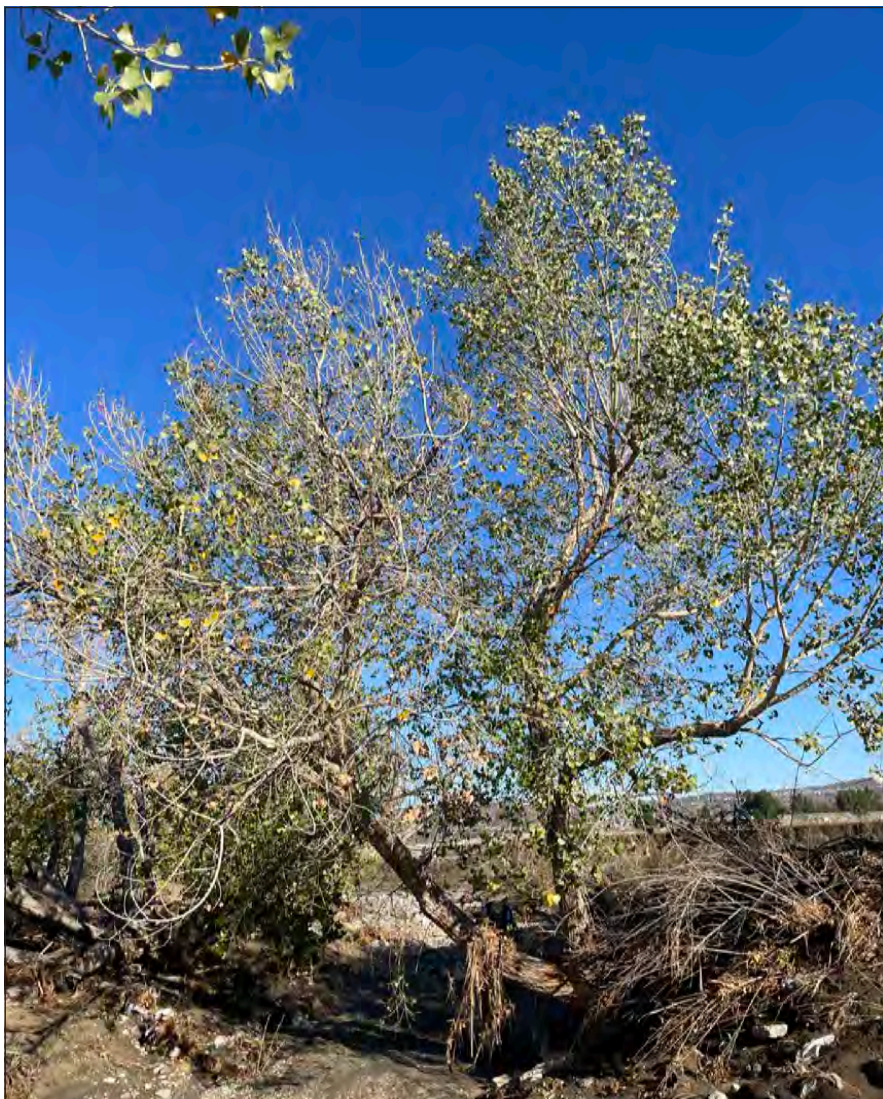
Photo 1. Tree 14 (Fremont cottonwood, rated C) within Honby Creek, facing approximately north.

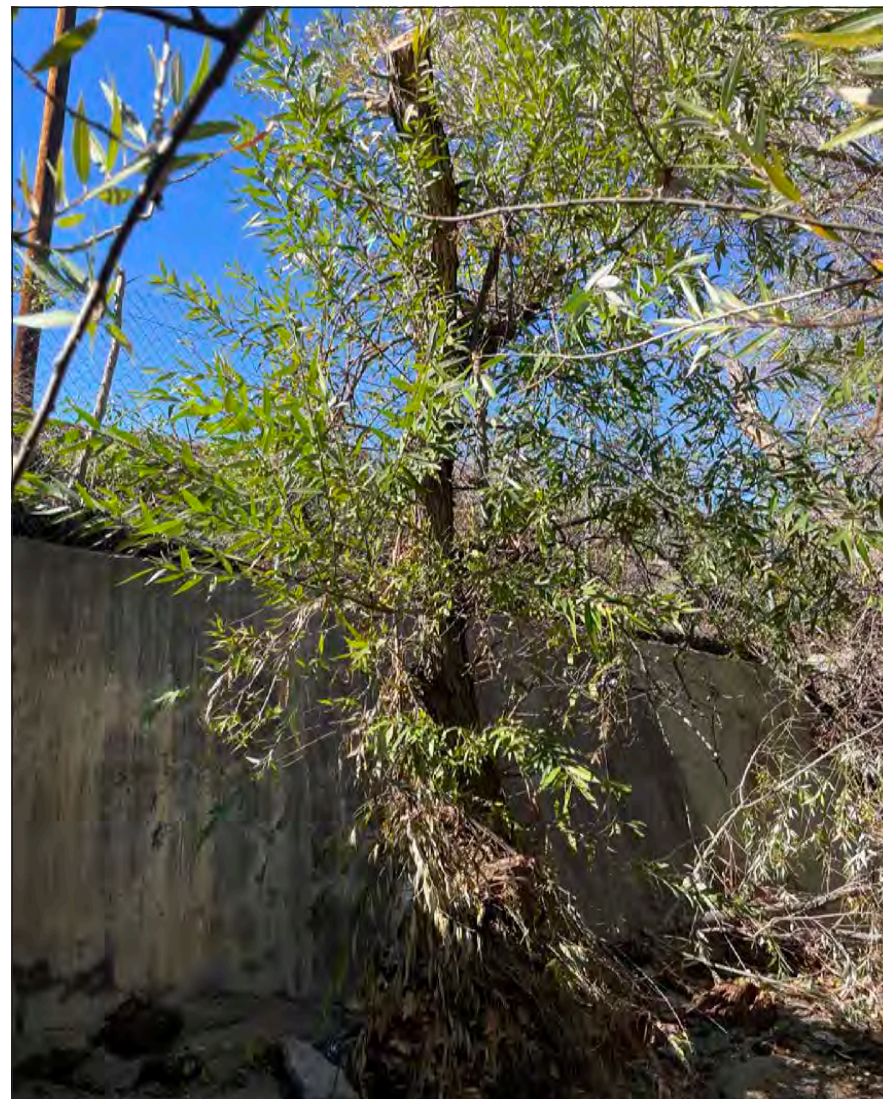
Photo 2. Tree 36 (red willow, rated C) within Honby Creek, facing approximately south.

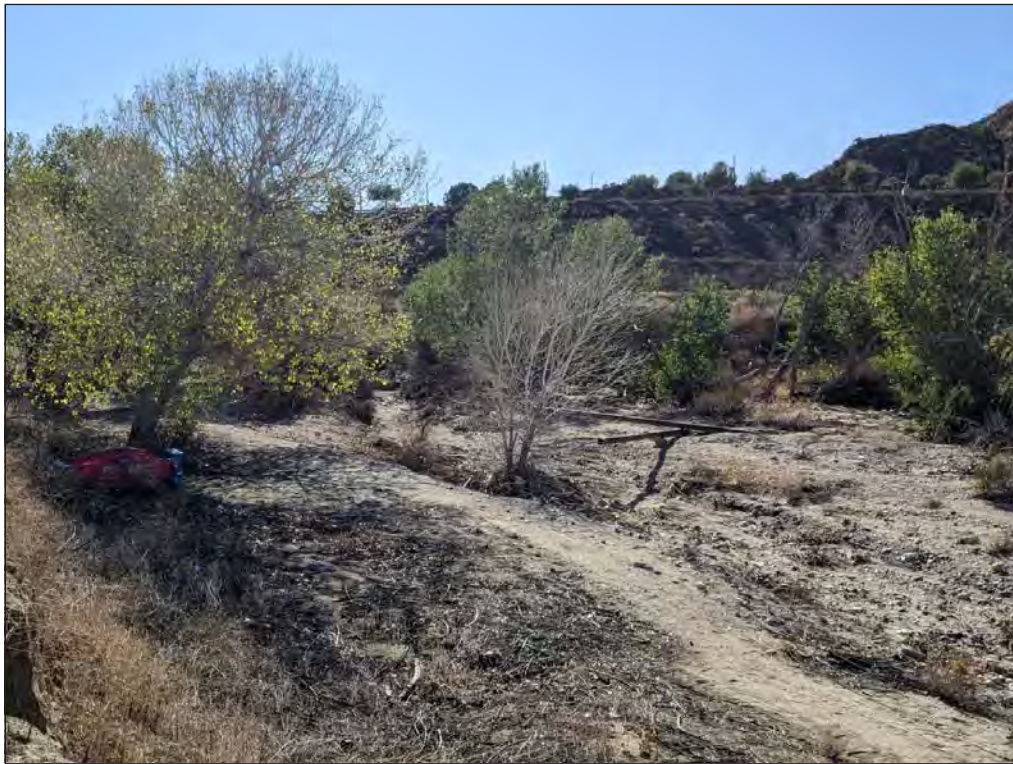
Photo 3. A view of the trees in Honby Creek, facing approximately southwest.

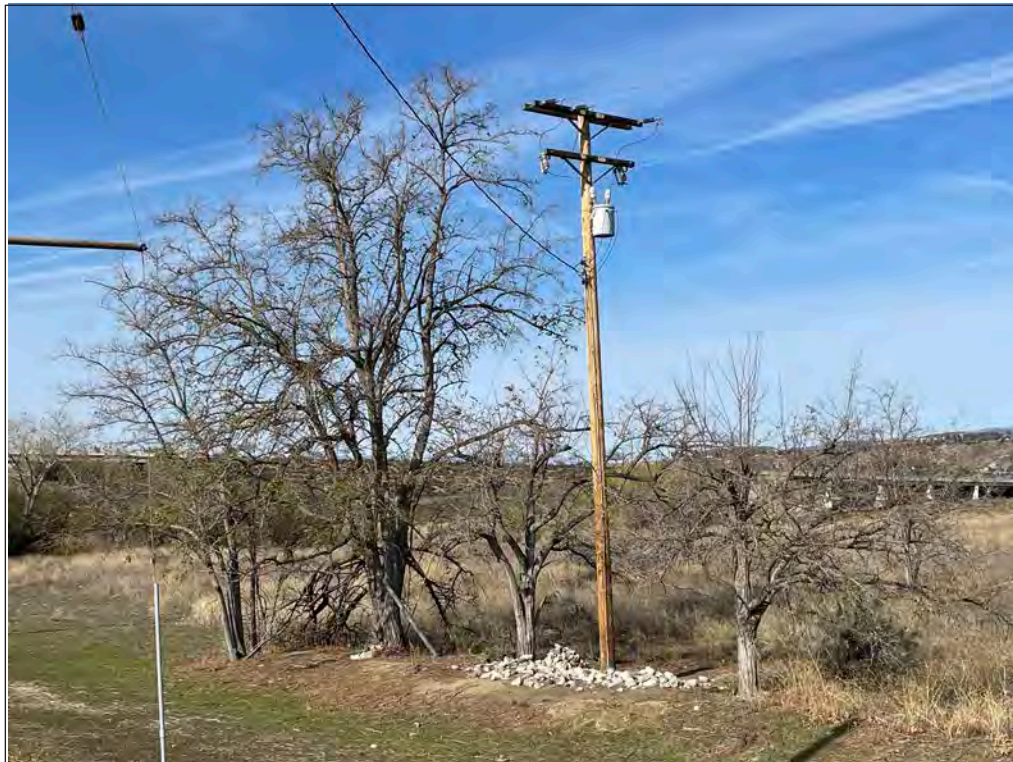
Photo 4. A view of the black locust trees (Trees 41-45, all rated D) to the north of the Metrolink station, facing approximately northwest.

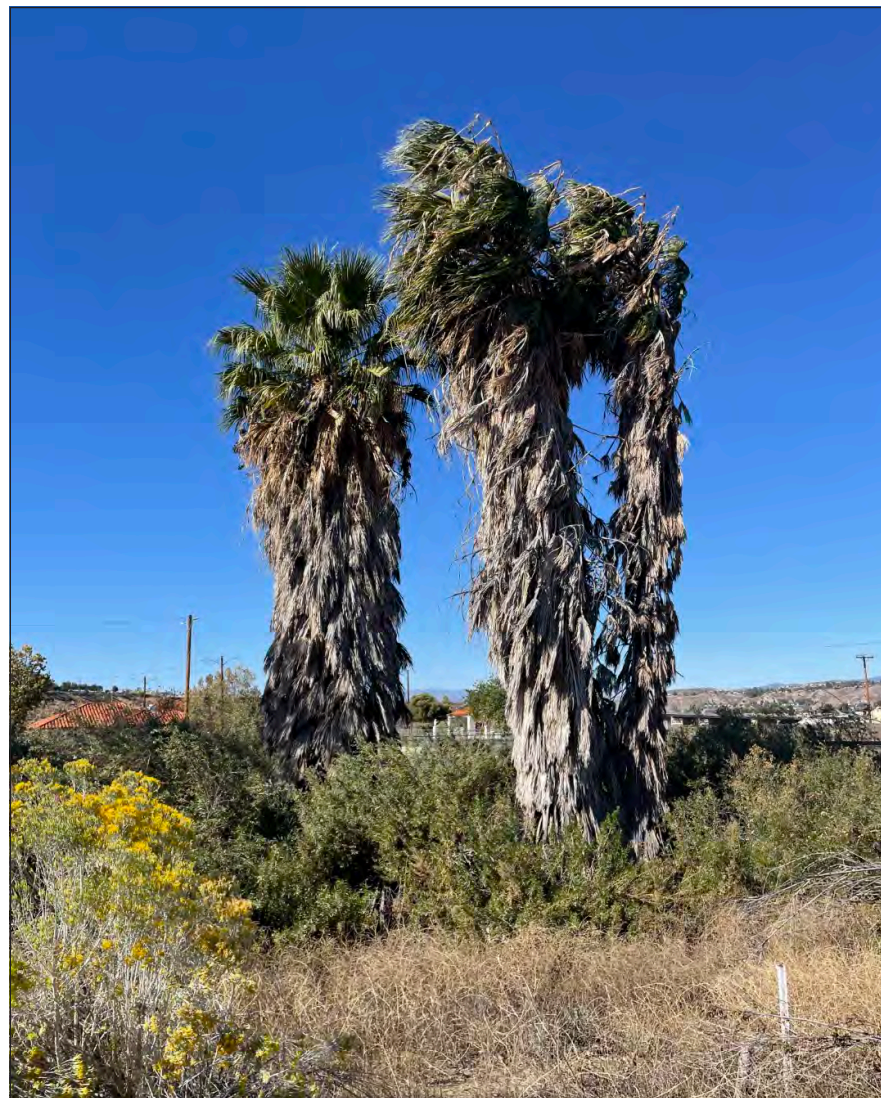
Photo 6. A view of the Mexican fan palms (Trees 51-54, all rated A) in the unnamed drainage to the west of Weyerhauser Way, facing approximately northwest.

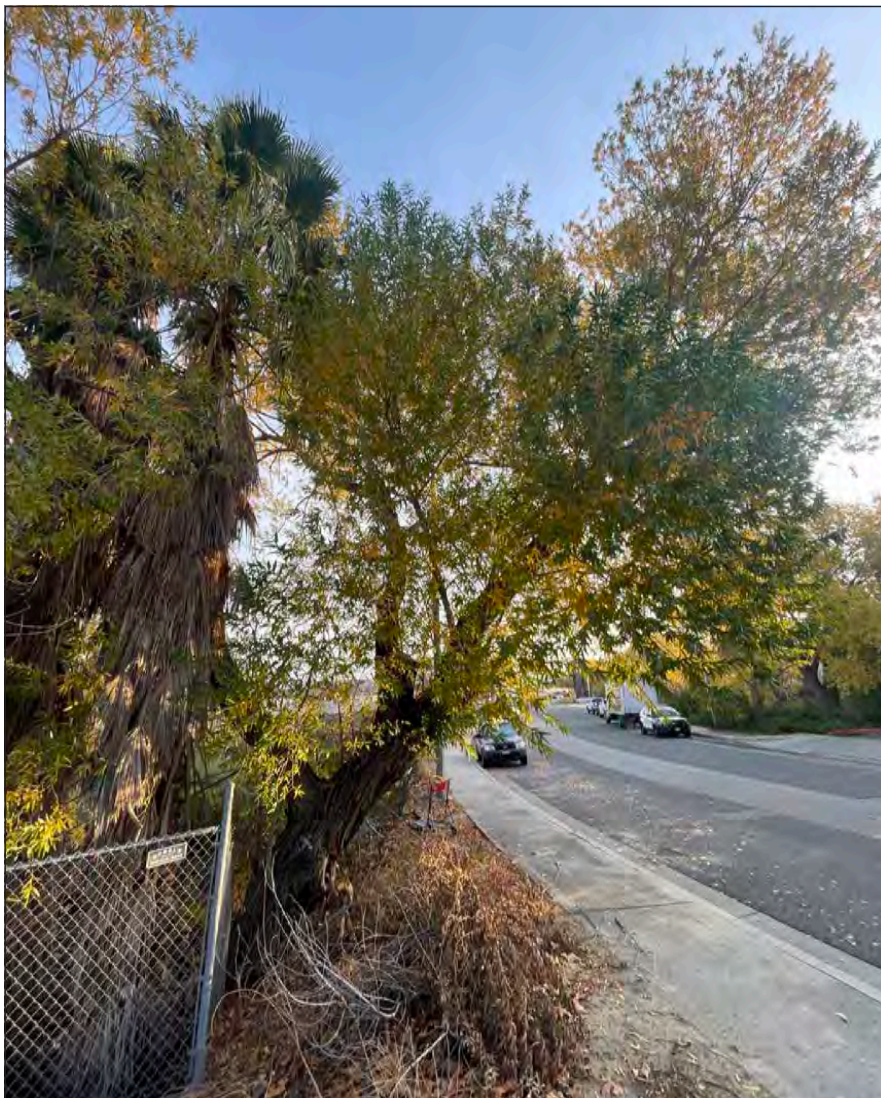
Photo 7. Tree 55 (Goodding's willow, rated B) in the unnamed drainage to the west of Weyerhauser Way.

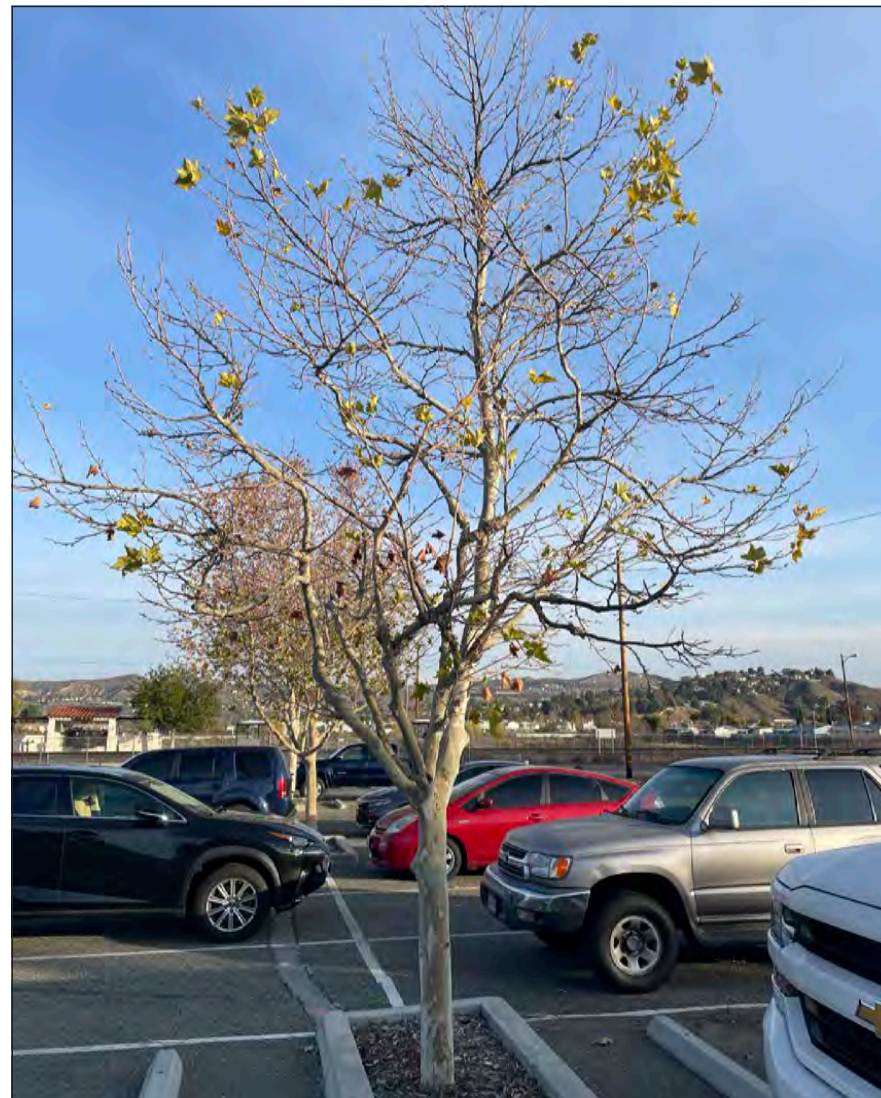
Photo 8. Tree 61 (London plane tree, rated B) in the Metrolink parking lot, facing approximately north.

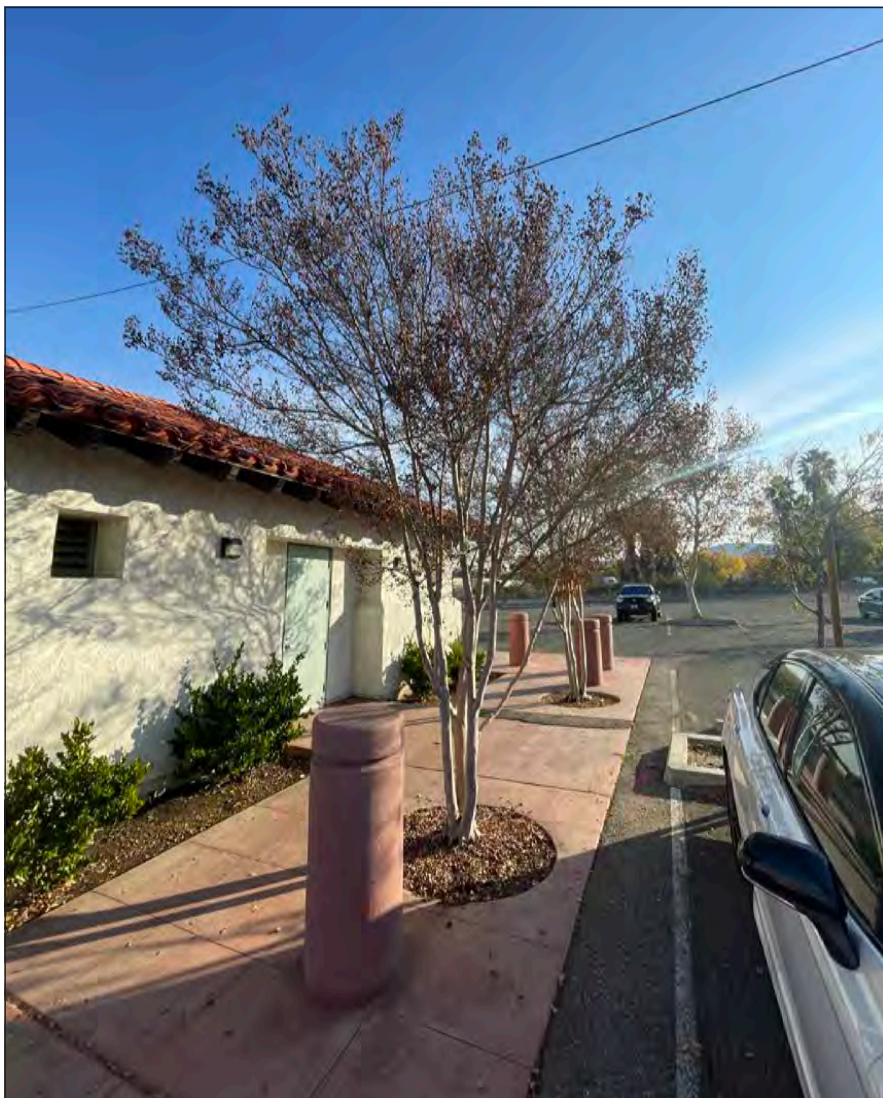
Photo 9. Tree 67 (crapemyrtle, rated A) in the Metrolink parking lot, facing approximately northeast. Tree 66 (crapemyrtle, rated A) can be seen in the background.

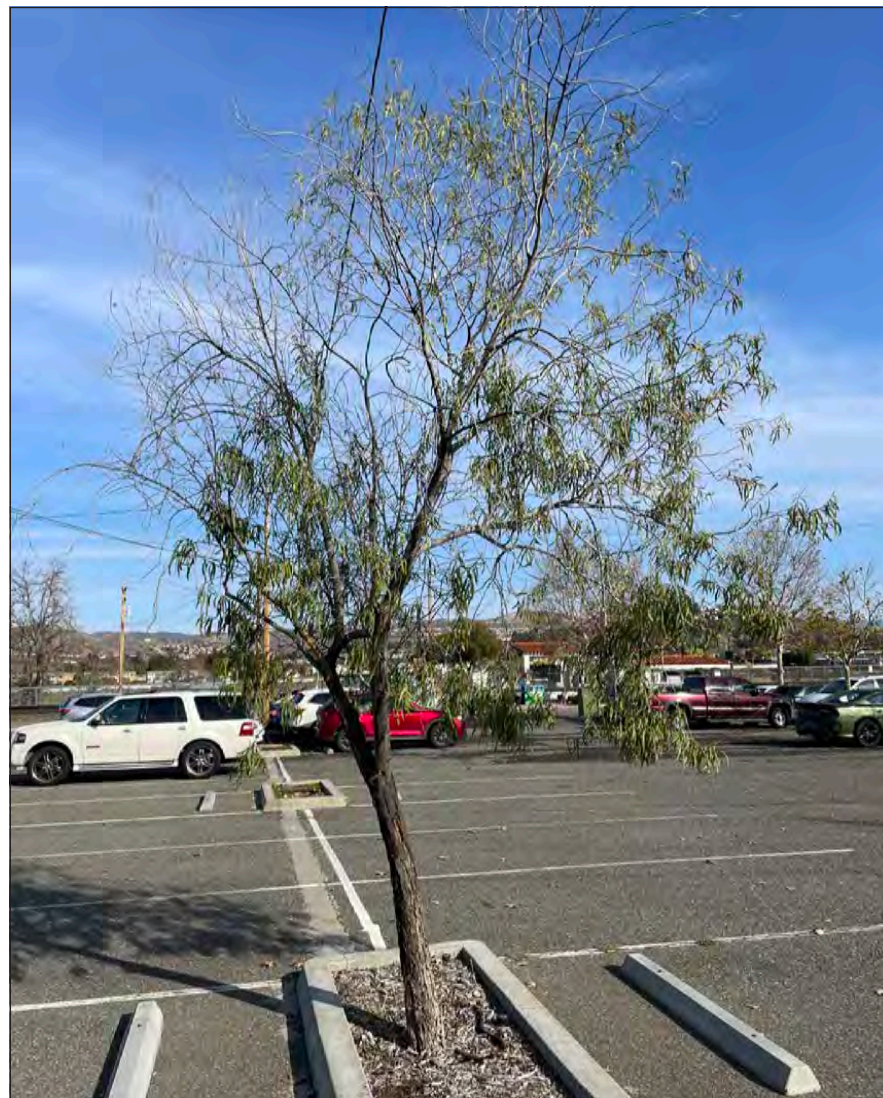
Photo 10. Tree 82 (Australian willow, rated D) in the Metrolink parking lot, facing approximately north.
