**ALLAN E. SEWARD**  
**ENGINEERING GEOLOGY, INC.**  
Geological And Geotechnical Consultants

**GEOLOGIC/GEOTECHNICAL REPORT**  
***EIR-Level Review of Road Alignment for Via Princessa East from Golden Valley Road to  
250 Feet West Of Sheldon Avenue***

City of Santa Clarita, California

Job No: 10-2254C  
Dated August 13, 2010

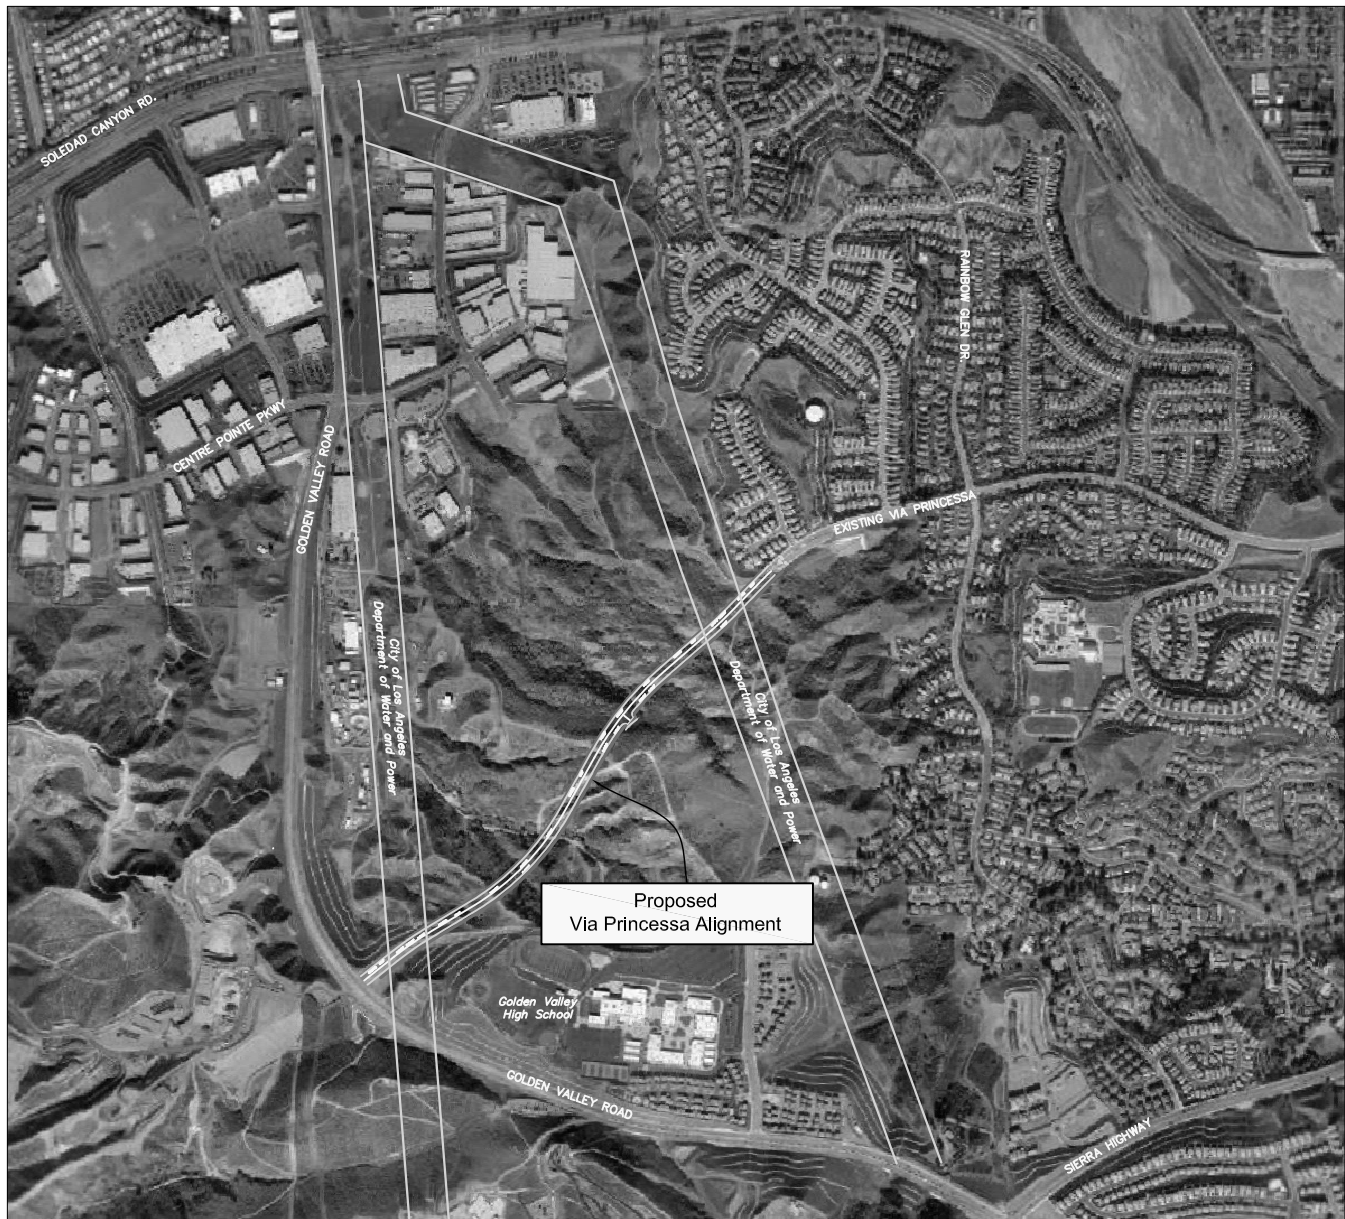
*Approximate Scale: 1"=1,500'*

*Aerial Photo dated July 27, 2008*

The proposed alignment shown on the attached Road Alignment Plan for Via Princessa East consists of extending Via Princessa from the existing Golden Valley Road intersection, just north of Golden Valley High School, to the northeast connecting to the existing westernmost extension of Via Princessa located approximately 250 ft west Sheldon Avenue. The proposed alignment is approximately 4,570 feet (0.87 miles) long and traverses property owned by Pacific Crest Santa Clarita, LLC., Gunjit Sikand, NTS property and Golden Valley High School property. Proposed slopes are designed at 2:1 horizontal to vertical gradients (h:v). The maximum proposed cut-slope is approximately 125 ft high and the maximum proposed fill slope is approximately 100 ft high. The proposed design shown on the Road
